RESERVE STUDY  
For  
**Southwind**

**Arlington, TX**  
Date of Inspection  
July 18, 2013

**BUILDING RESERVES, INC.**

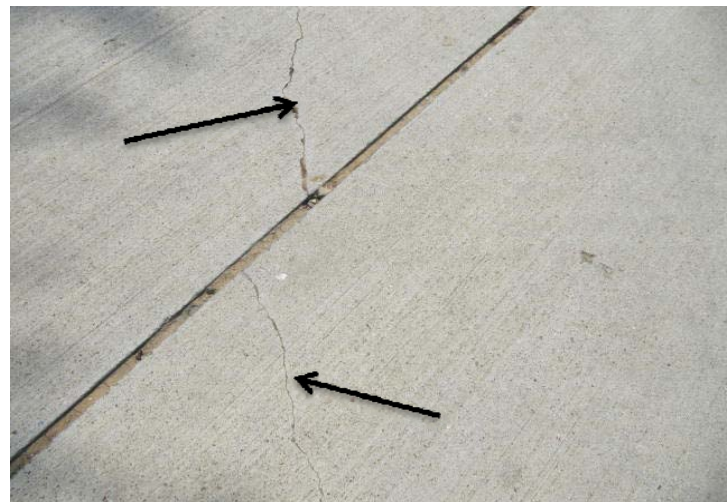
Cracks at concrete parking lot.

Special Conditions
<p>Total quantity includes the concrete parking lot located next to the swimming pool and amenity center. Concrete flatwork is in good overall condition at 7 years of age. A 25.0% replacement is forecasted within the next 30 years, beginning in 2022. Replacement years coincide with concrete sidewalk replacements.</p>

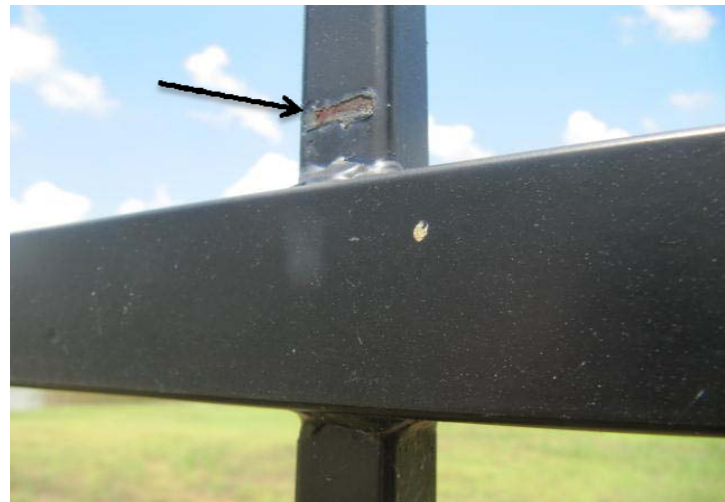
Isolated condition of worn finish & surface oxidation.

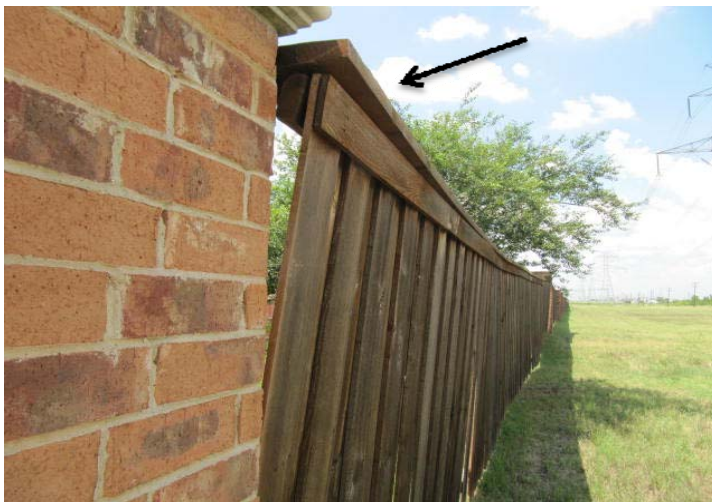
Isolated condition of detached fence section.

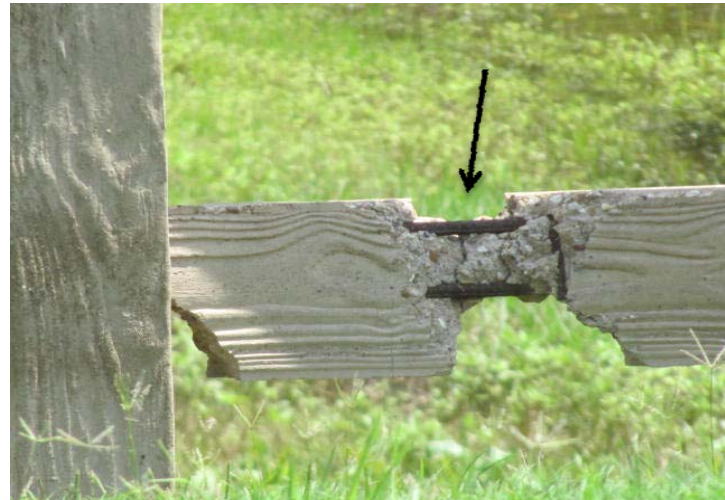
Isolated condition of damaged fence rail and exposed reinforcing bars.

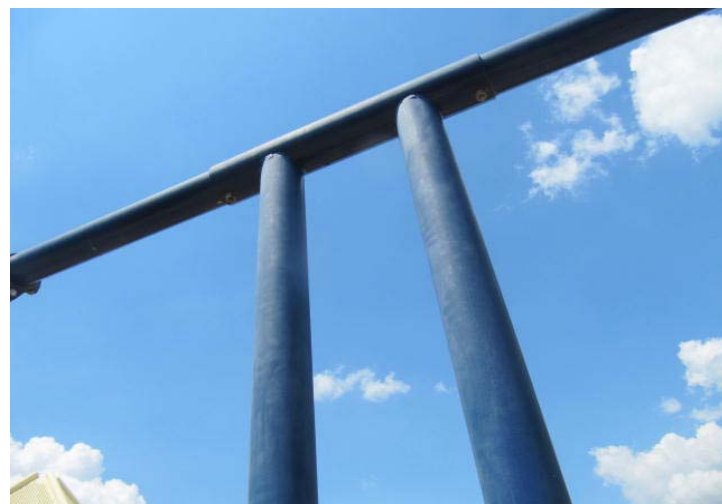
Worn finishes at swing set structure - fund paint finishes through operating budget.

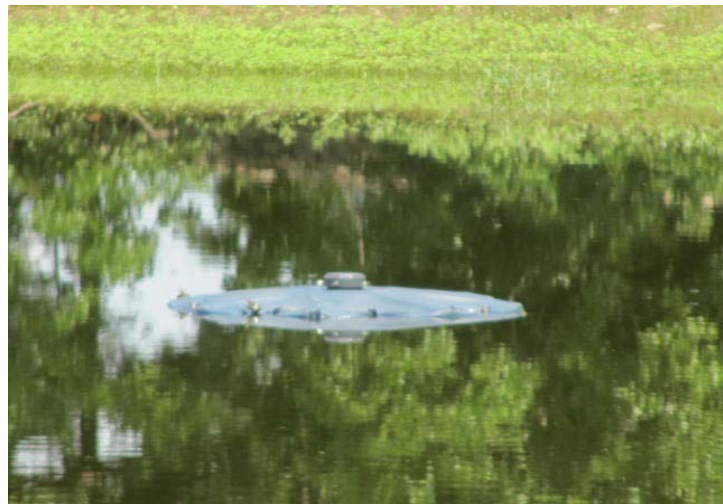
Non-operational aerator at front pond (low water level).

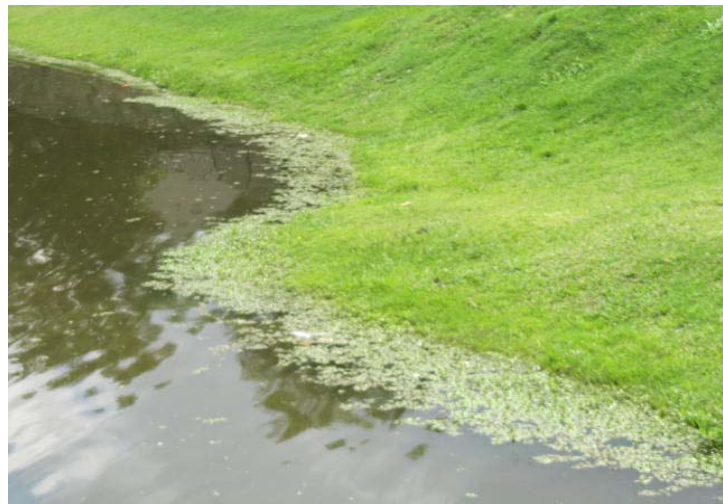
Accumulated organic growth at edge of pond.

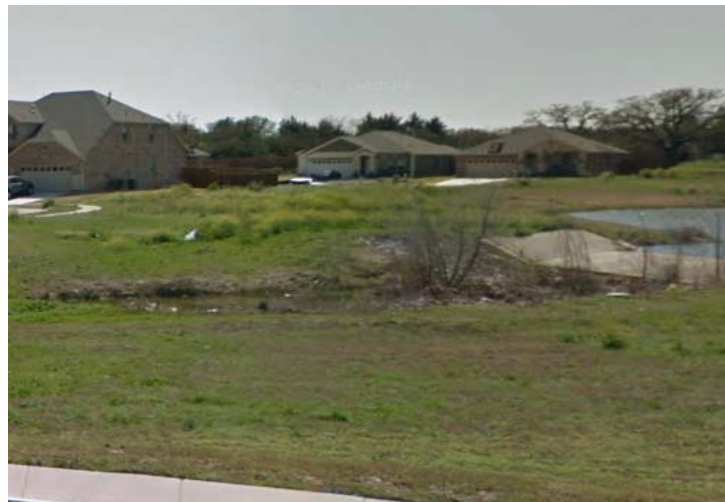
Area with accumulated brush and debris.

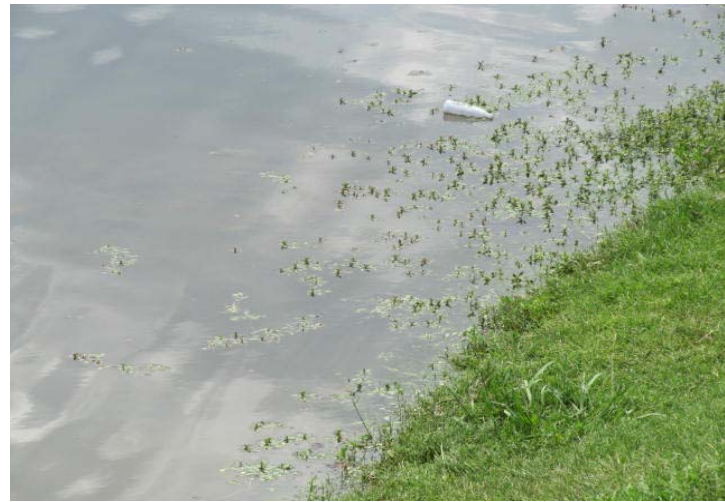
Low water at front pond area.

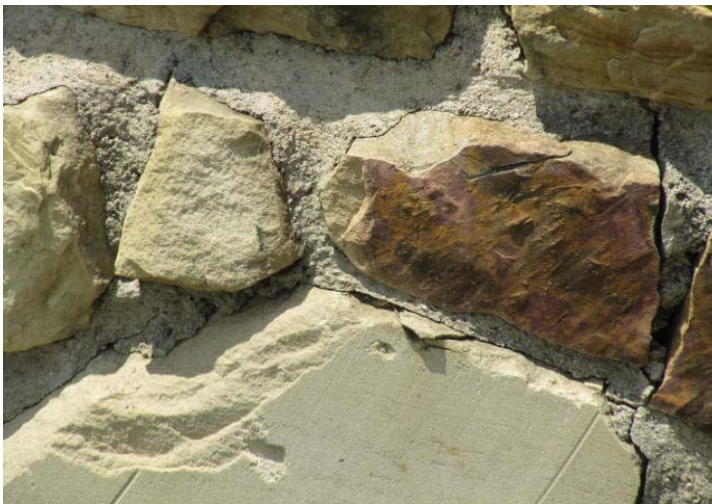
Cracked mortar joints at stone retaining wall.

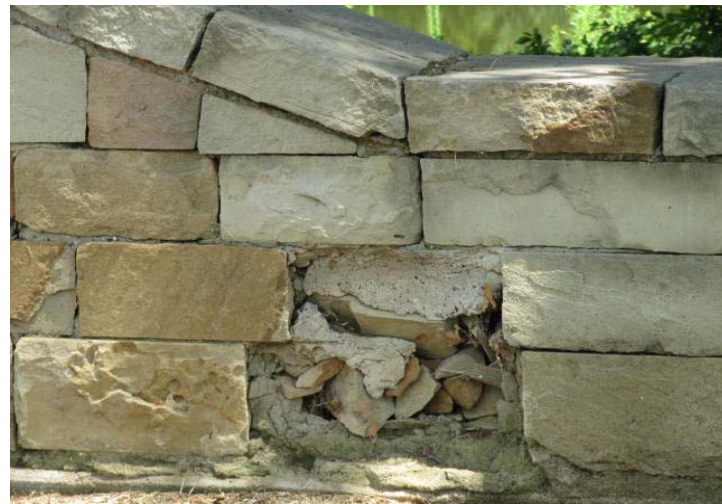
Damaged stone wall along entrance drive at Southwind Drive.

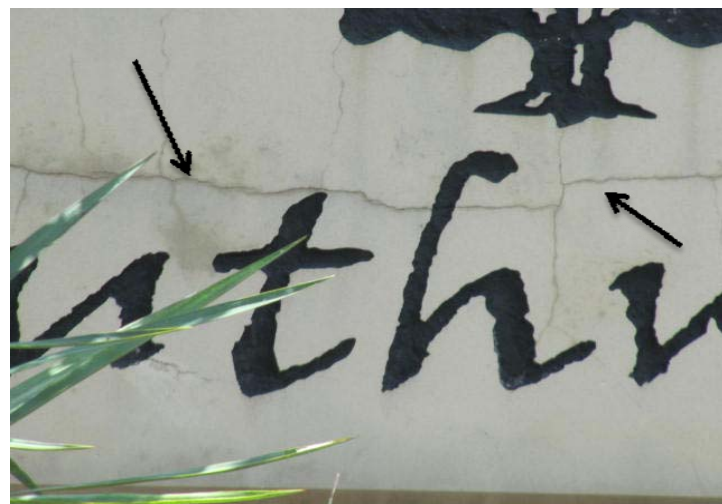
Cracks at precast signage at perimeter wall.

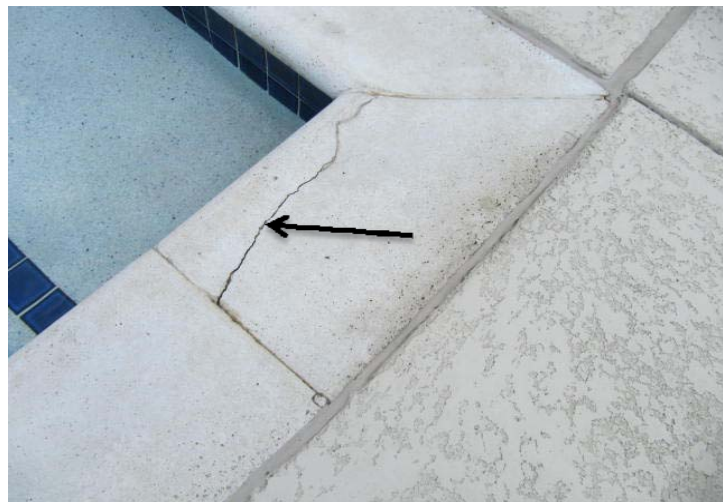
Cracked coping section at pool perimeter.

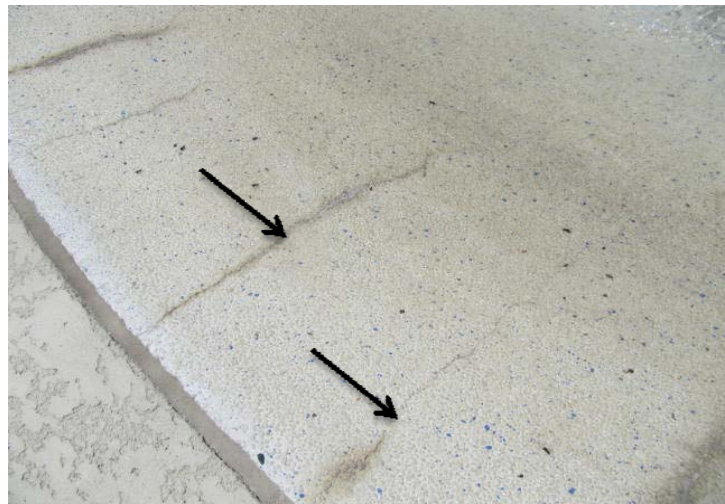
Cracks at pool finish near zero-depth area.

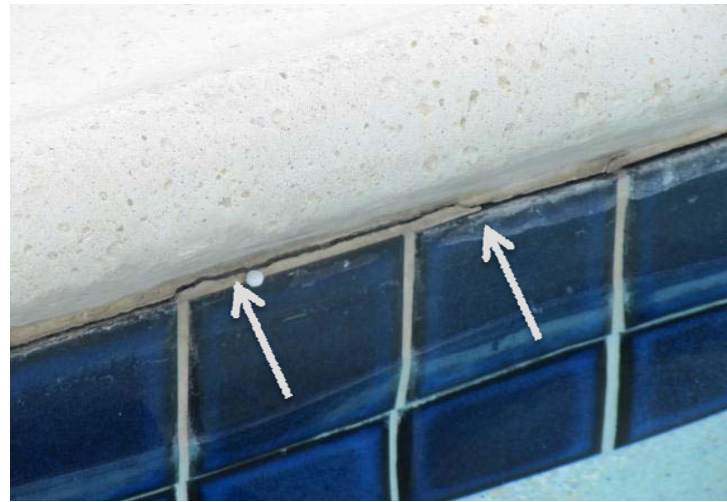
Isolated condition of mortar in poor condition at top of waterline tile.
