RESERVE STUDY  
For  
**Southwind**

**Arlington, TX**  
Date of Inspection  
July 18, 2013

**BUILDING RESERVES, INC.**

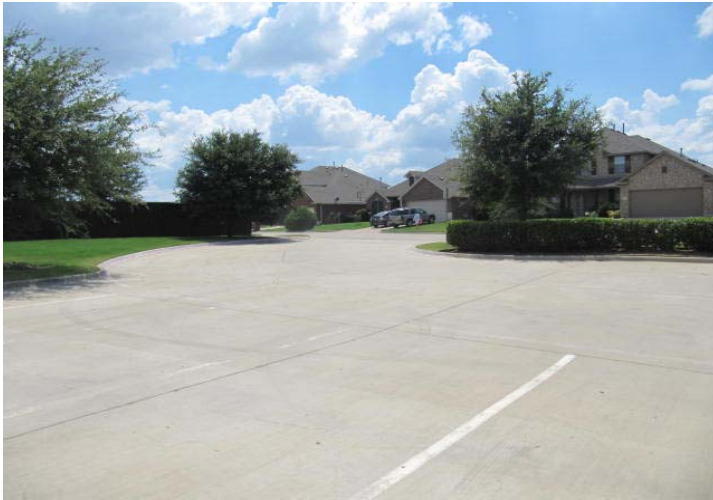
Overview of concrete parking lot.

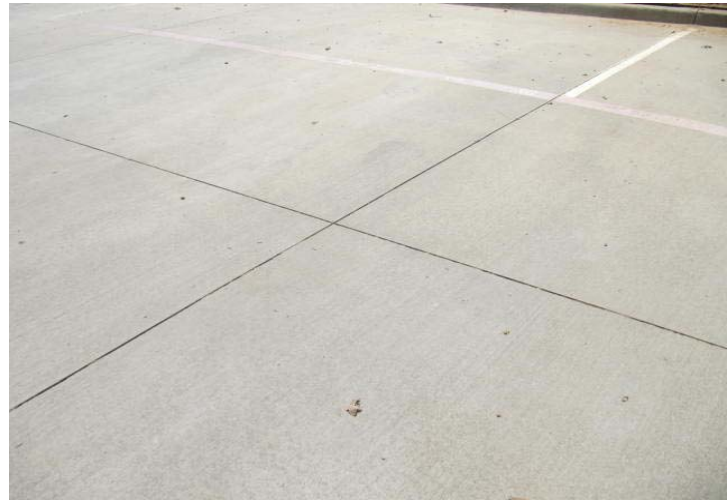
Concrete flatwork, with saw-cut control joints.

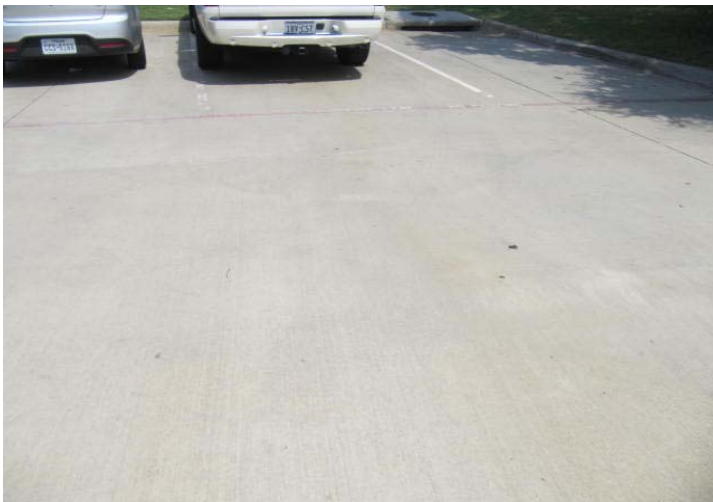
Typical condition of concrete flatwork at parking lot.

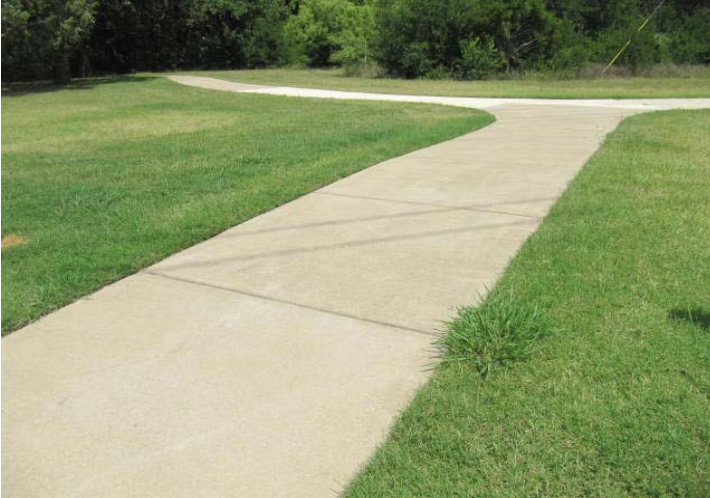
Overview of concrete sidewalks at walking trail.

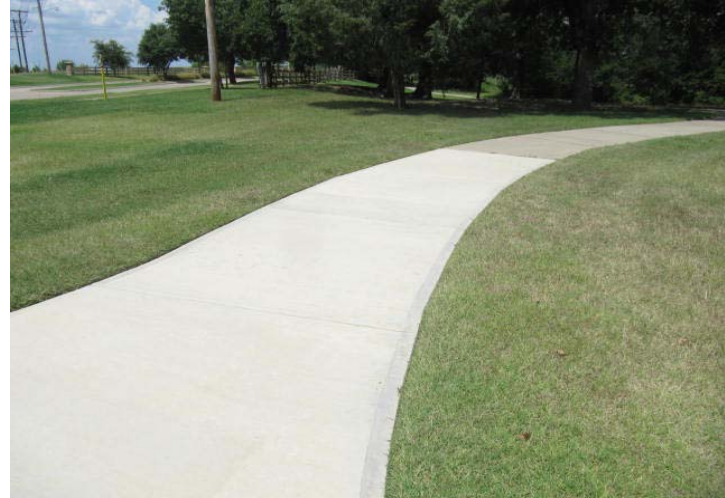
Newer section of concrete flatwork.

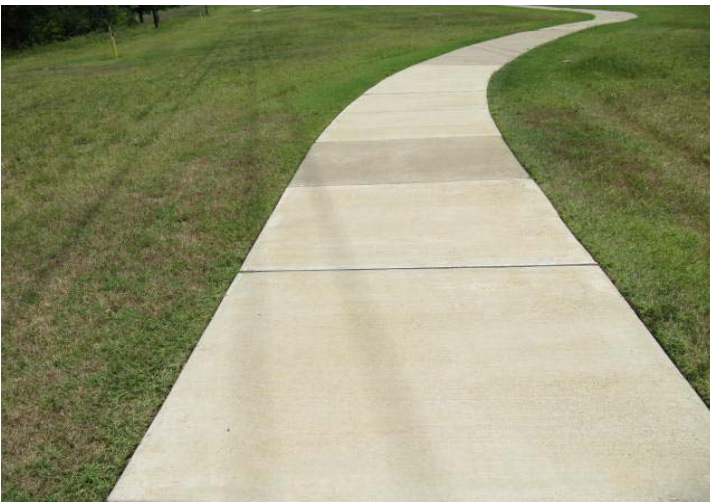
Concrete flatwork, of varying ages.

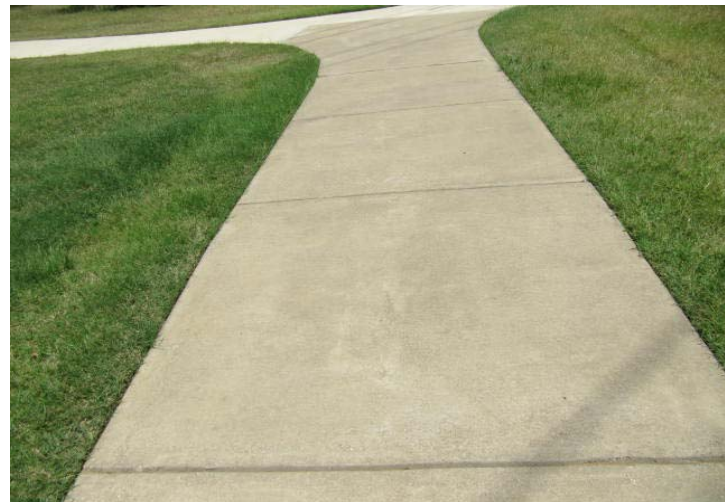
Concrete sidewalk at walking trail.

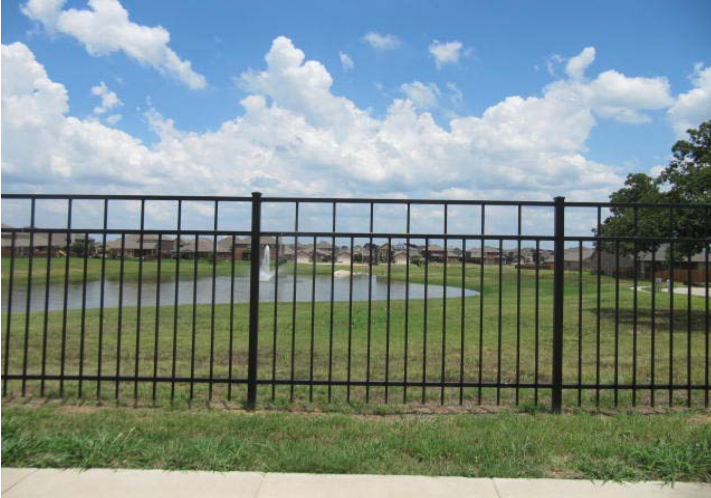
Overview of metal fence at property perimeter.

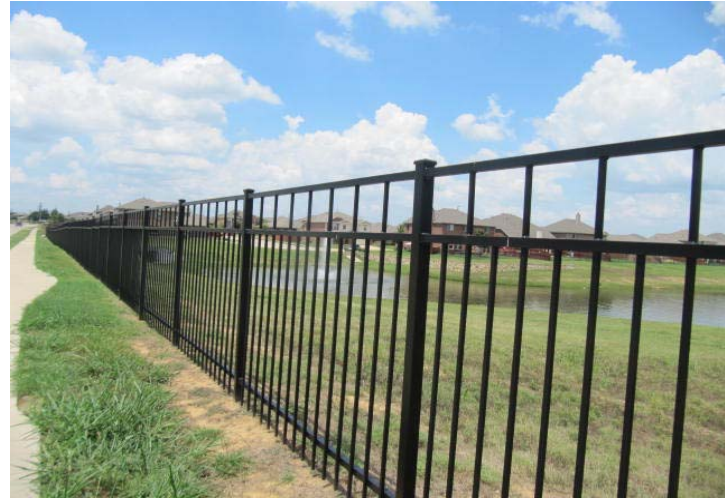
Metal picket style fence, in good condition.

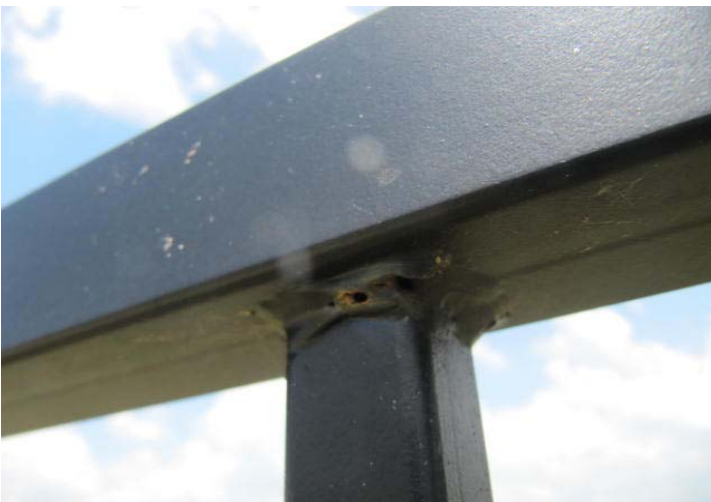
Typical condition of finishes at metal fence.

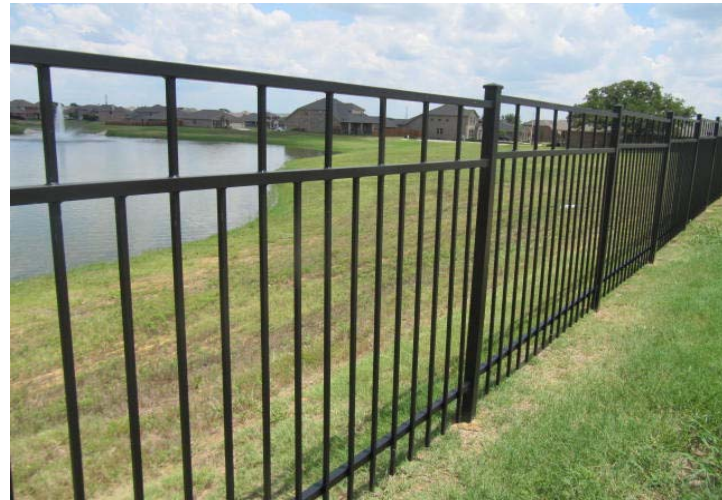
Overview of metal fence at property perimeter.

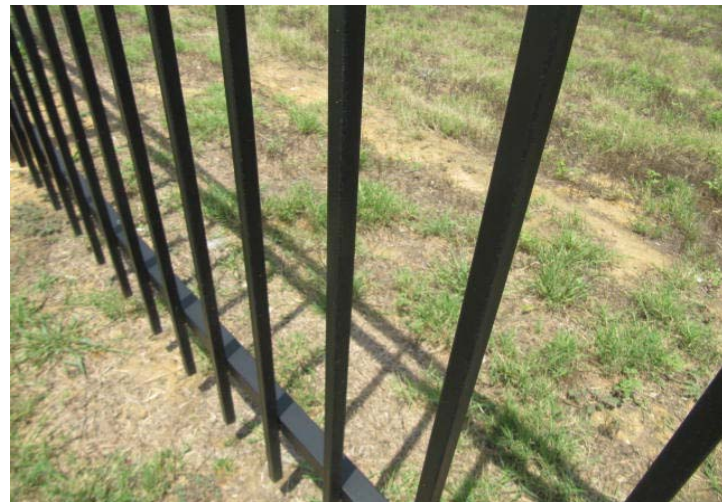
Typical metal pickets at fence.

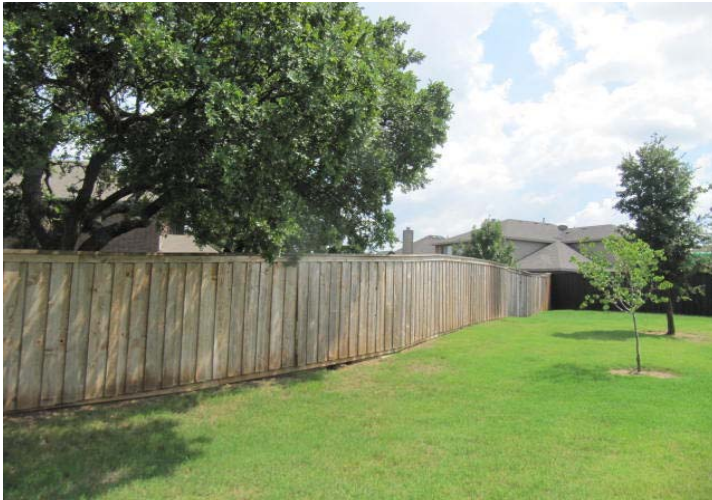
Wood fence near pool/playground area.

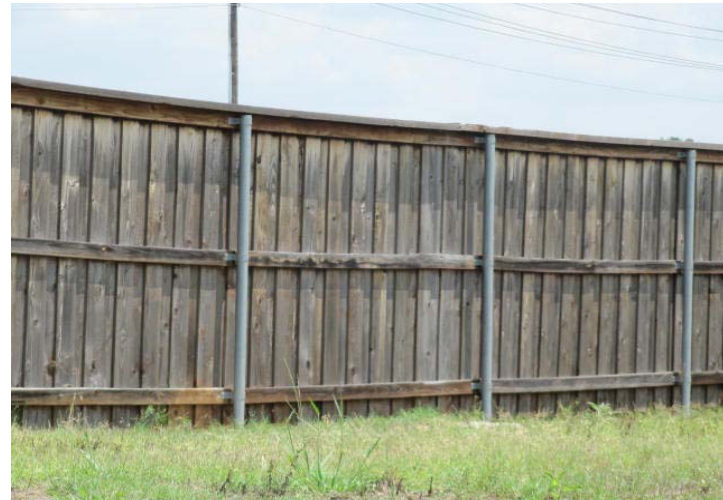
Wood privacy fence along transmission line easement.

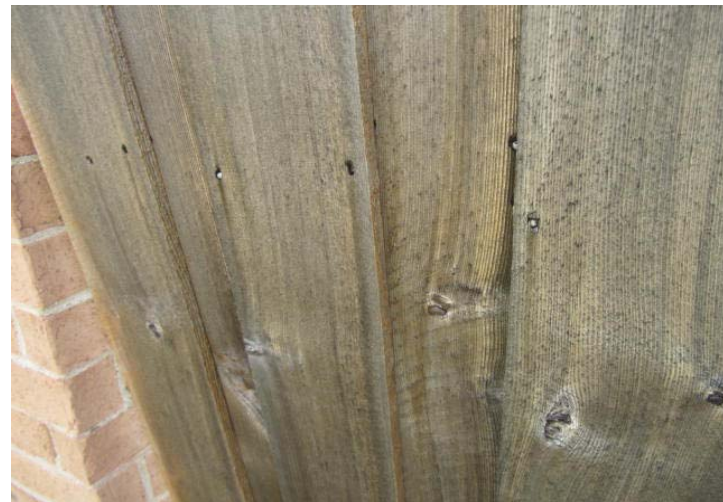
Typical condition at wood pickets at fence.

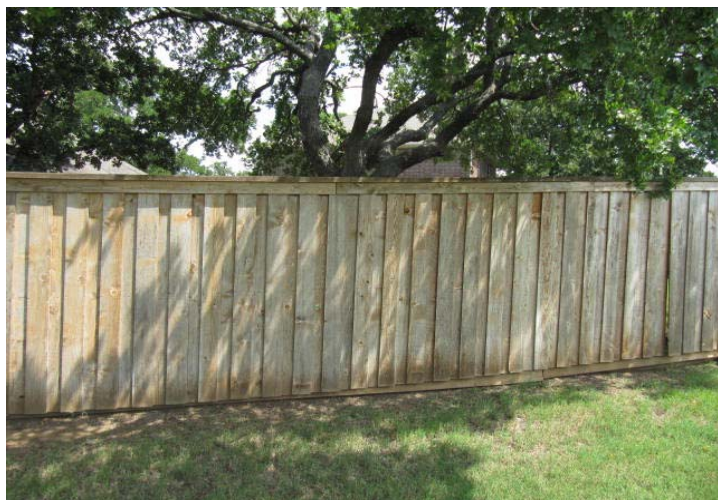
Wood fence near pool/playground area.

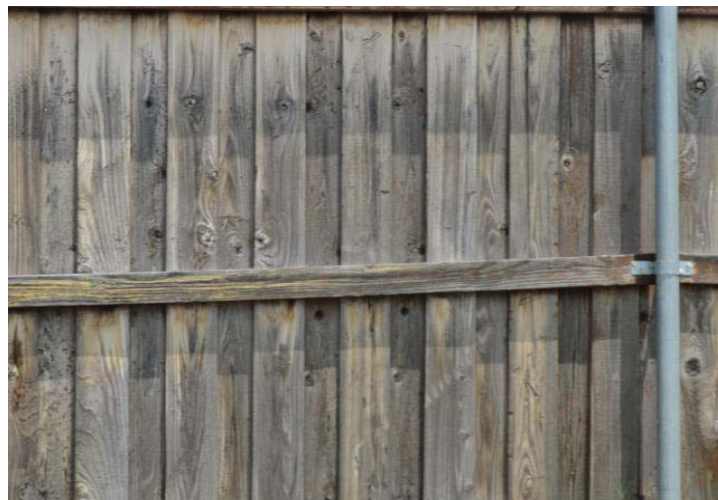
Wood privacy fence along transmission line easement.

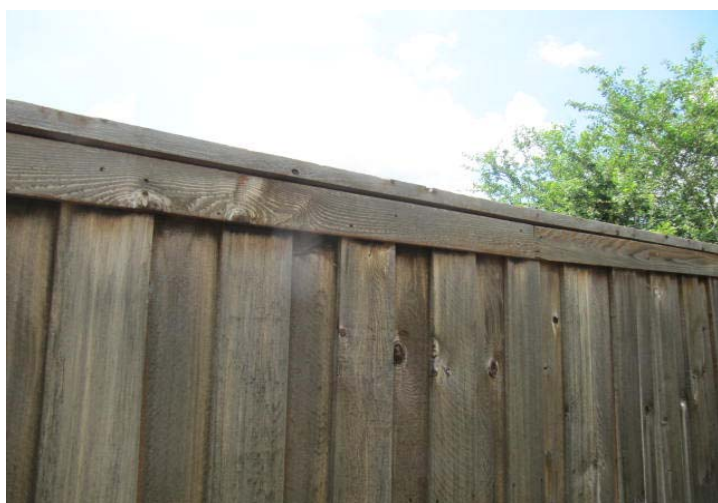
Typical shadow box style fence with top rail.

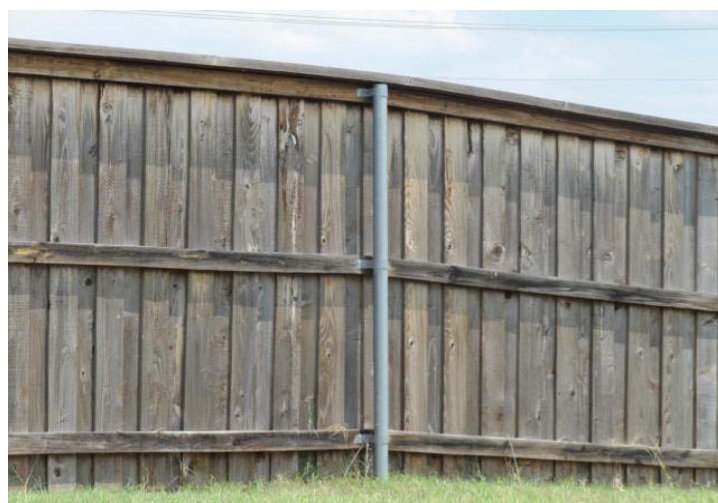
Typical metal post at rear of fence, with wood pickets.

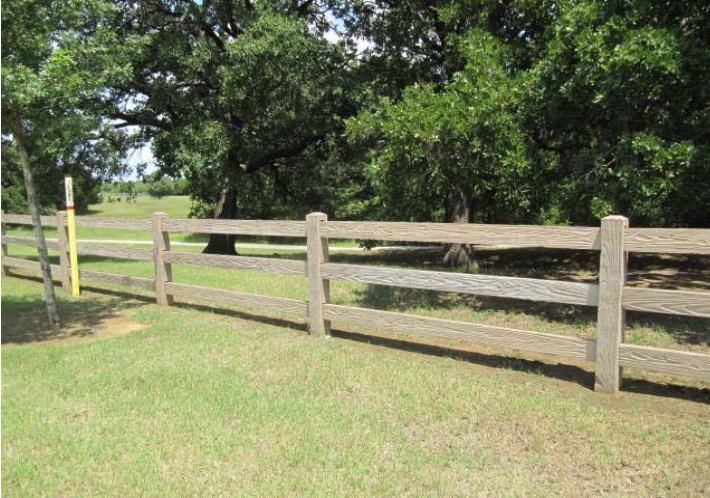
Overview of rail style fence.

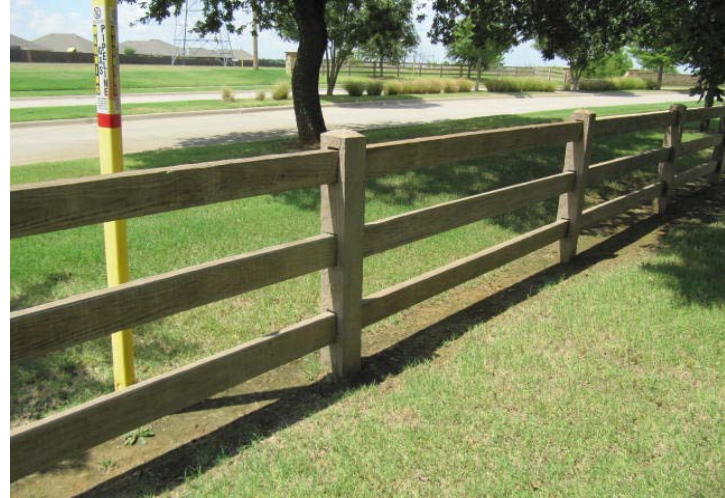
Concrete 3-rail fence, in good condition.

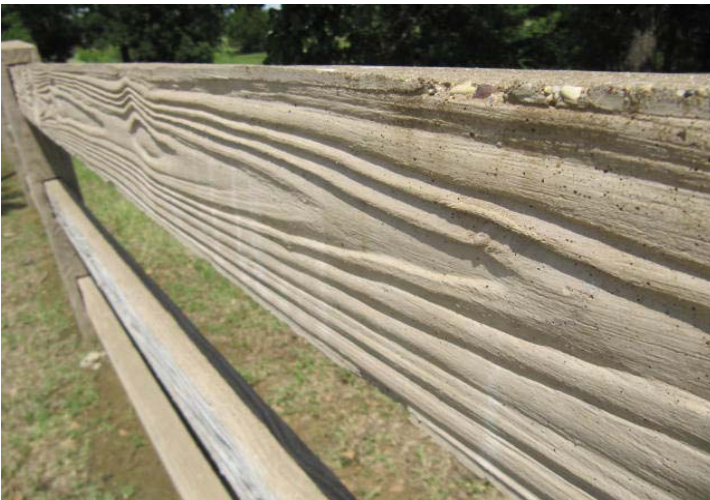
Typical textured formed concrete fence rail.

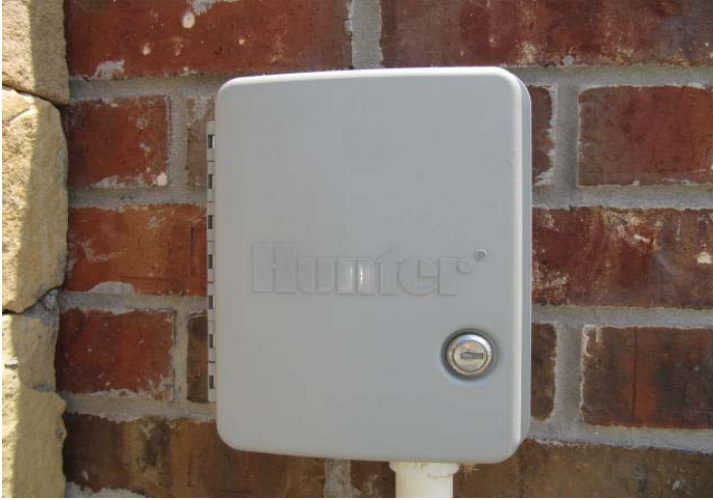
Irrigation controller / timer.

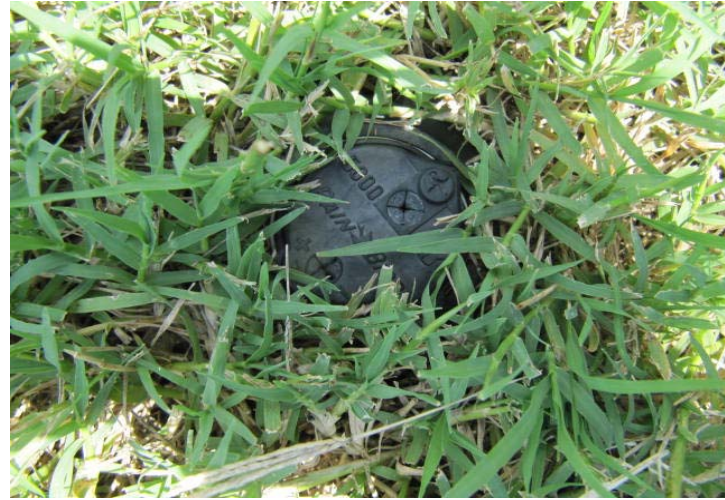
Irrigation sprinkler head at lawn area near pond.

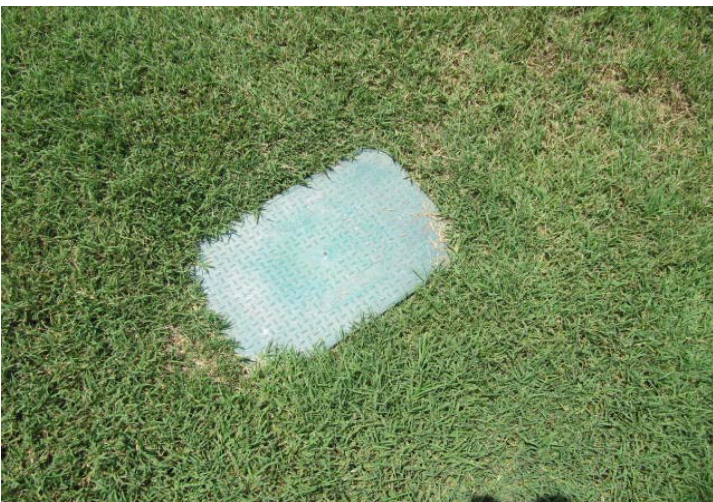
Cover at irrigation control valve.

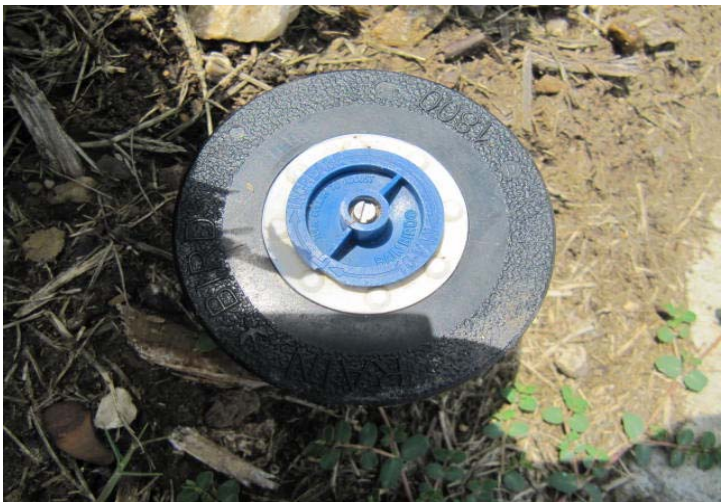
Irrigation sprinkler head at planting bed near monument sign.

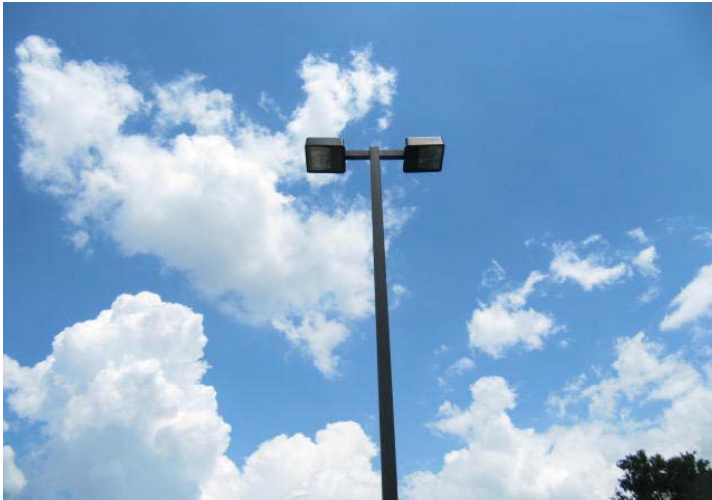
Overview of light pole and fixture at parking lot.

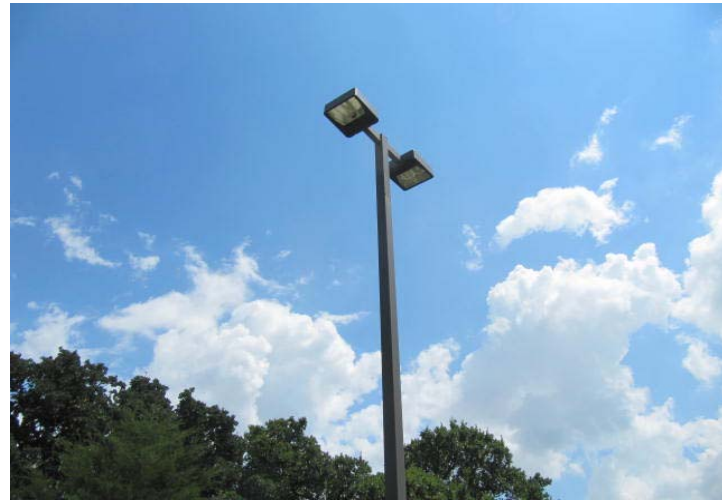
Duplex fixture at light pole.

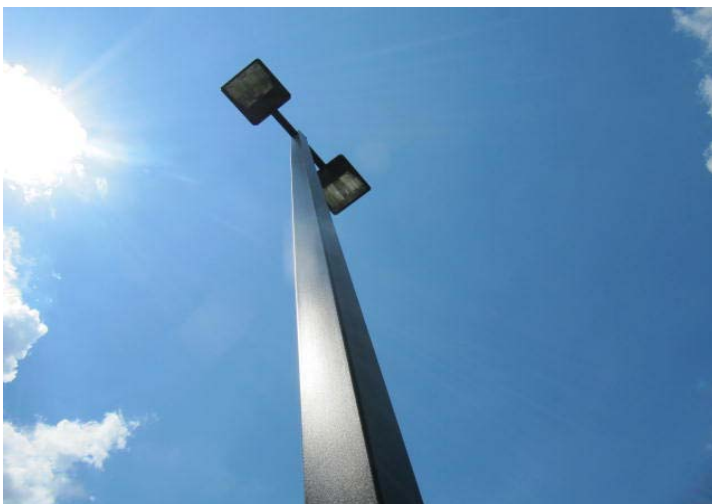
Duplex fixture at light pole.

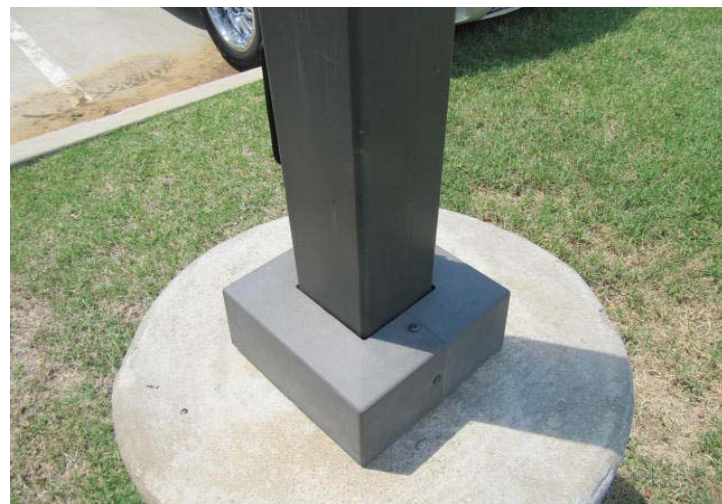
Aluminum base cover at light pole.

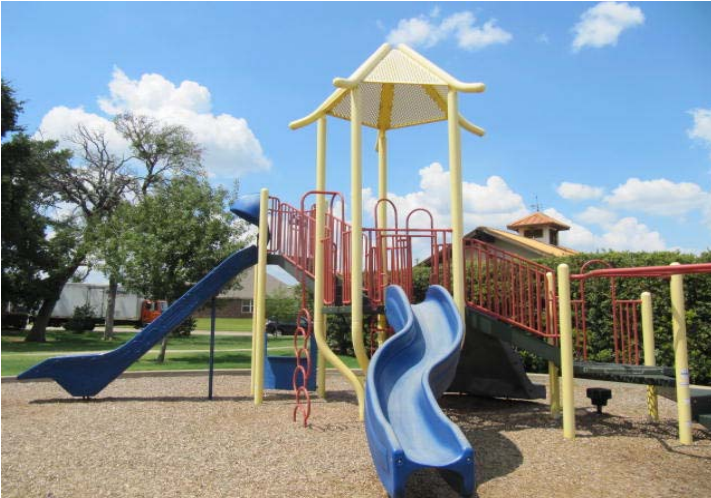
Playground structure at amenity center.

(1) commercial play structure wall is located at the playground area. The structure is in good overall condition at 7 years of age. Replacement is forecasted for 2028 and coincides with the replacement of the adjacent climbing wall and swing set. Prior to full replacement, paint finishes should be funded as needed as an operational expense.

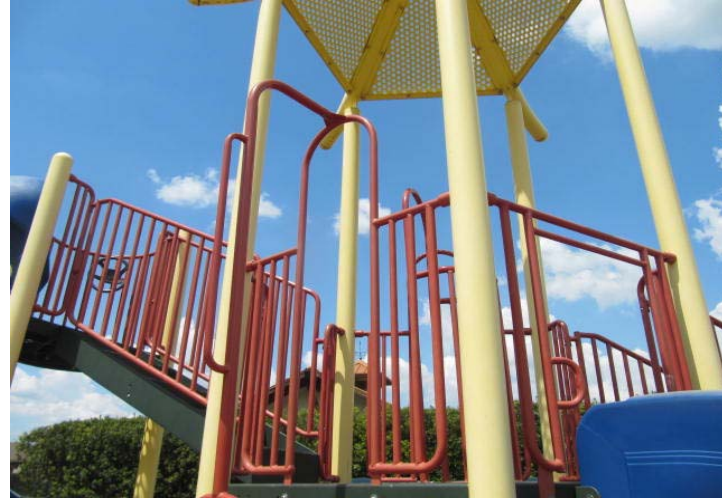
Tower and rails at playground structure.

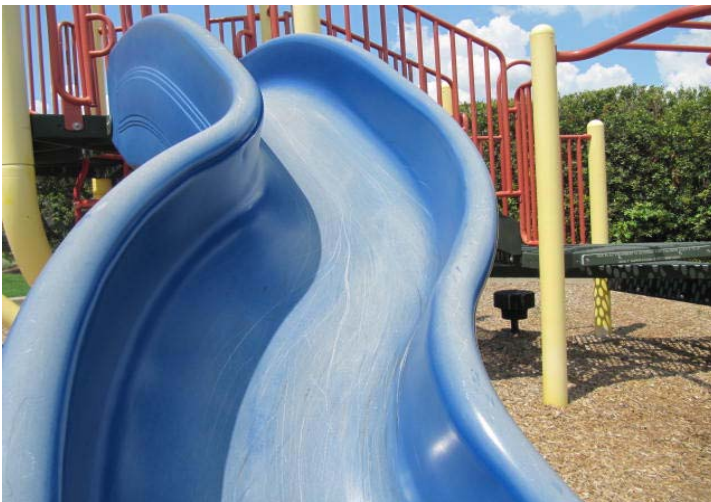
Markings at playground slide.

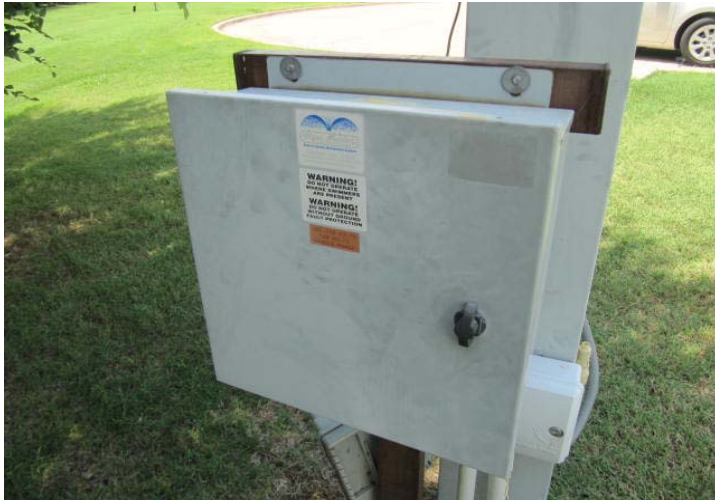
Overview of control box / timer.

Component includes the replacement of the pond aerator controllers / timers. The existing controllers / timers are in functional condition but are inaccurate. Replacement of the controllers / timers is forecasted for 2016 and every 10 years thereafter. In 2036, replacement coincides with the replacement of the pond aerators.

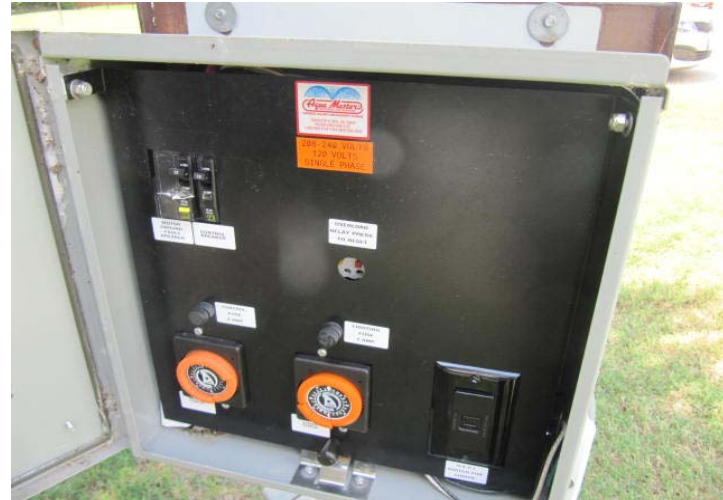
Control box / timer for pond aerator.

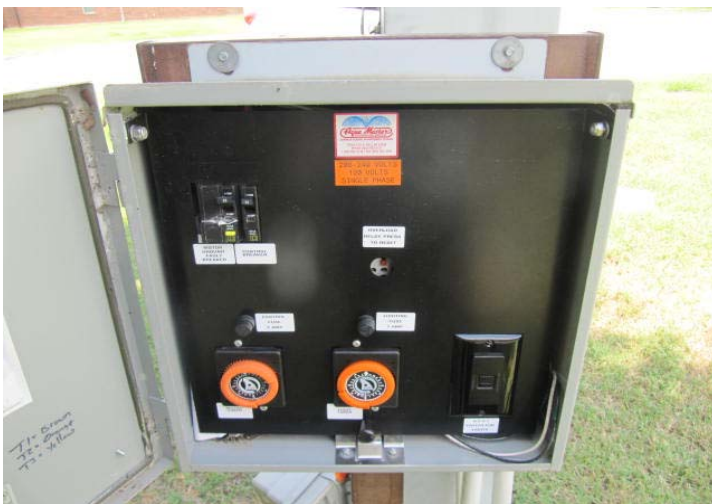
Timers, fuses, lighting switches, and breakers.

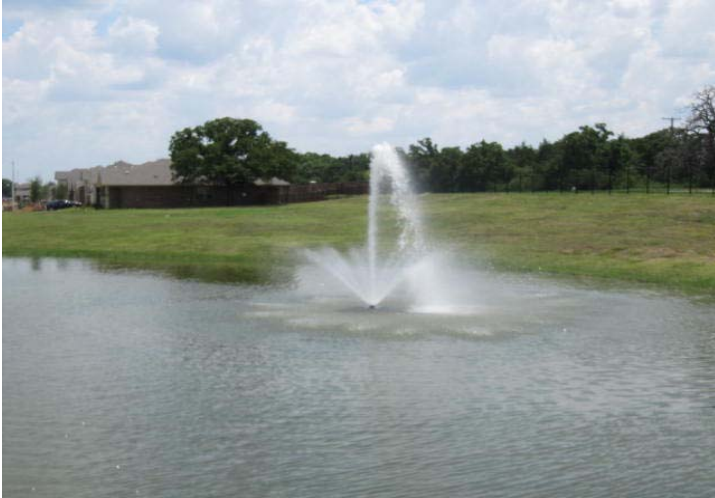
Overview of pond aerator.

The property's (4) aerators are in good functional condition at 7 years of age. Replacement of the pond aerators is forecasted for 2021, and again 15 years thereafter. Replacement in 2036 coincides with the replacement of the aerator controllers / timers. Near-term aerator lighting repairs should be funded from the association's operating budget due to low cost.

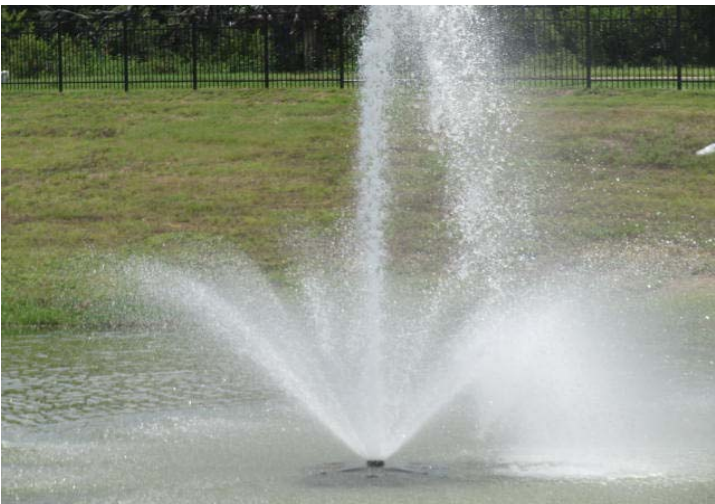
Pond aerator, in good functional condition.

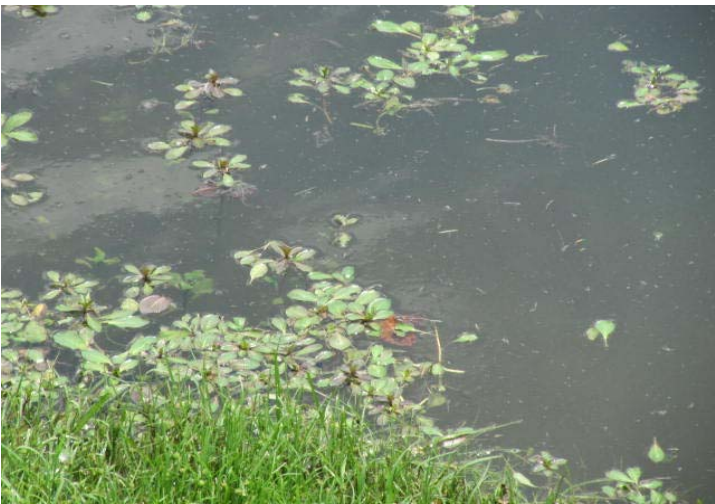
Stagnant pond water with plant growth.

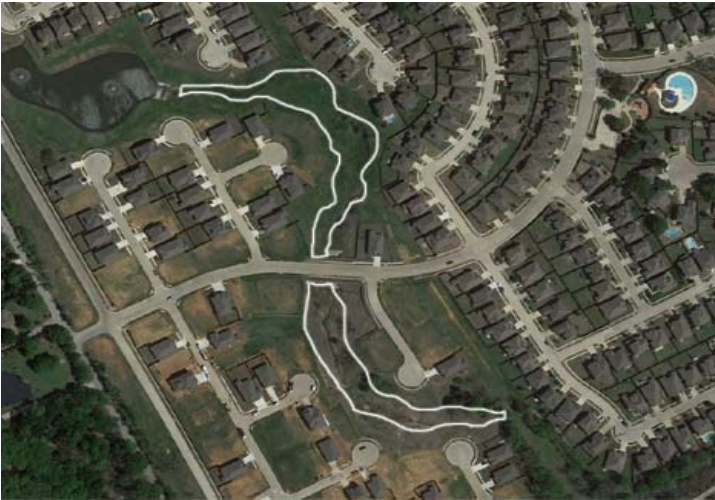
Area of proposed clearing / cleaning.

Special Conditions
Component includes proposed clearing and/or cleaning of the drainage spillway located at the Western side of the property. Cleaning / cleaning work may include picking up and disposal of debris, rental of equipment, movement of top soil, landscaping restoration / minimal plantings, etc. Initial clearing / cleaning is forecasted for 2017, and every 10 years thereafter.

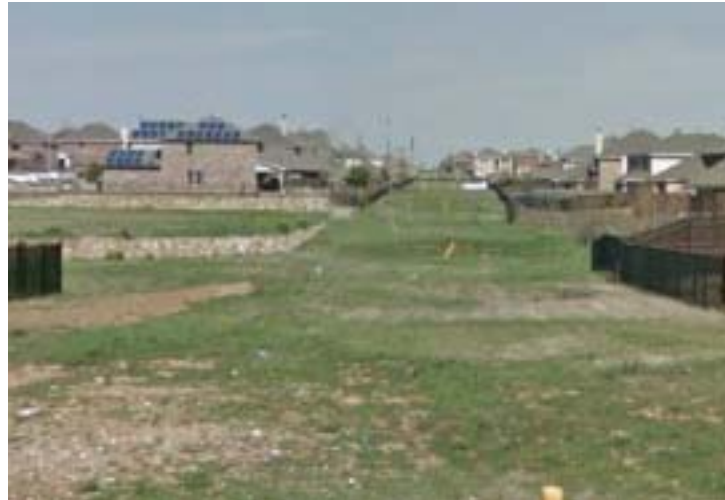
Spillway and draining area at Western side of property.

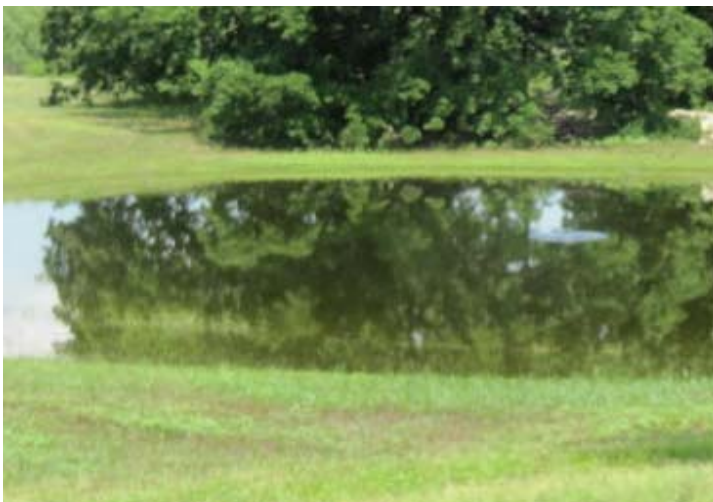
Low water at front pond area.

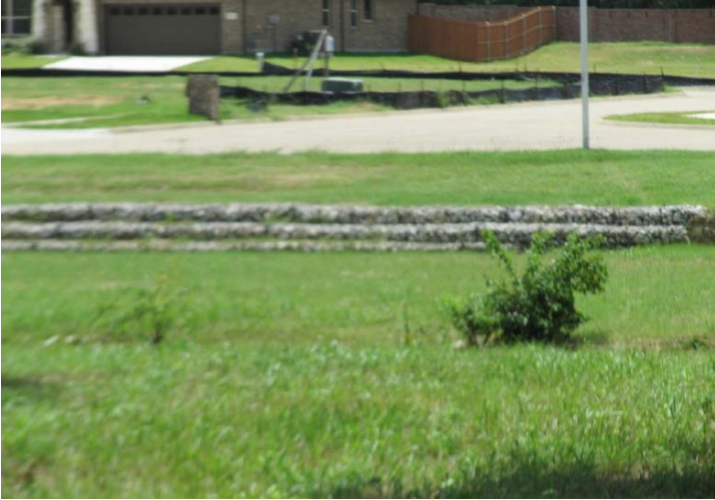
Gabion wall at common area.

Special Conditions
<p>A terraced gabion wall is located at the end of the cul-de-sad near Nellie Drive. The stacked stone-filled gabions are tied together with wire mesh. The terraced walls stabilize the sloped embankment and are in good overall condition at 7 years of age, with no major signs of movement or shifting. Replacement / rebuilding of the gabion walls is forecasted when the walls reach an age of 20 to 25 years.</p>

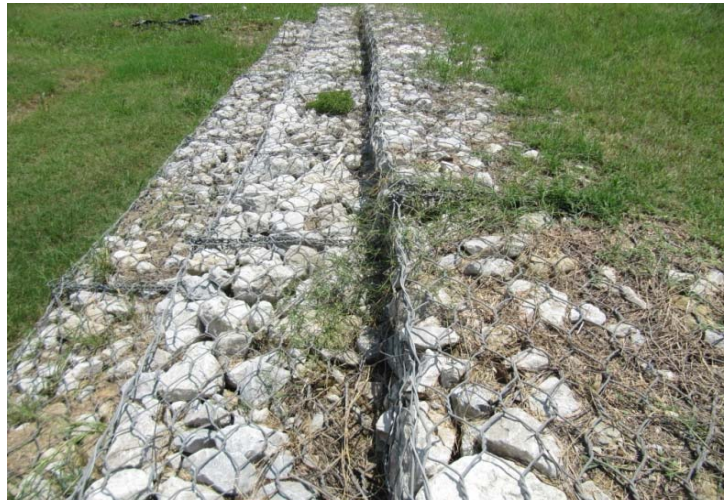
Stones and wire enclosure at gabion wall.

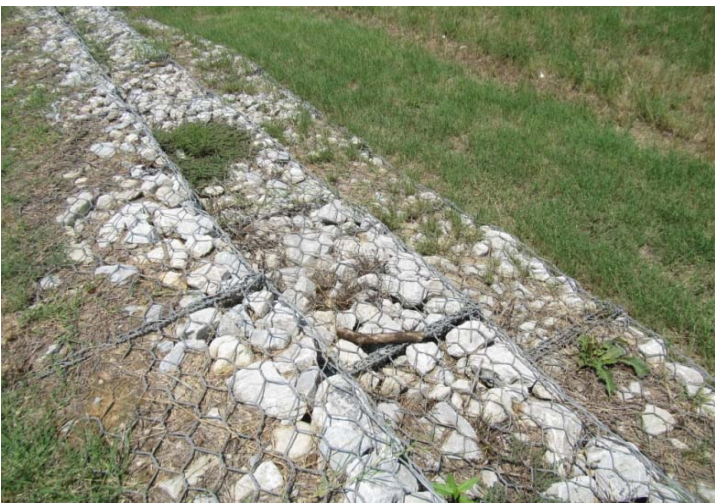
Stones and wire enclosure at gabion wall.

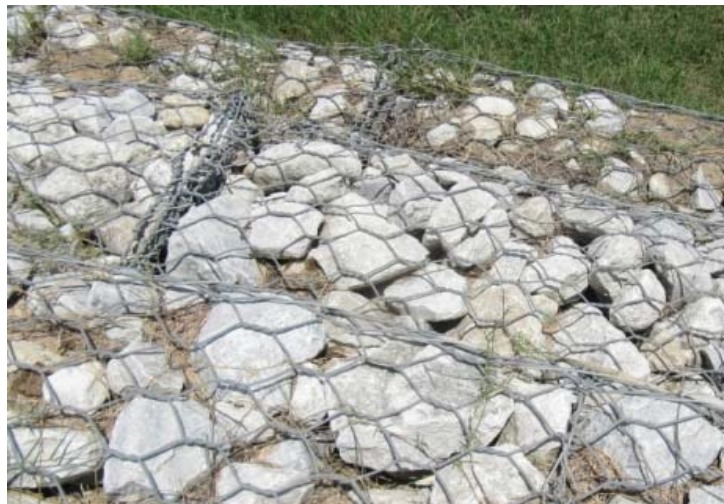
Terraced steps at gabion wall.

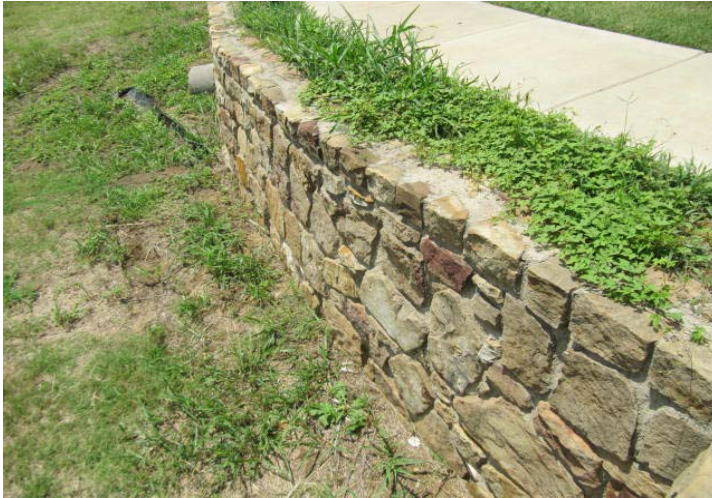
Retaining wall at end of cul-de-sac.

Special Conditions
Total quantity includes all masonry retaining walls at the following locations: Chalkstone/Cunningham area near pond entry, Water Oak Ct at end of cul-de-sac, Water Oak Dr. at West side of road, Waterwalk Ct at cul-de-sac, Corbin Ct. at cul-de-sac, and the picnic area near the pond at Southwind Drive. Total quantity also includes the stone walls at the Southwind Dr. entrance. Capital repairs are forecasted every 15 to 20 years. All other walls at homeowner yards and/or streets are the responsibility of the property owner whose earth is retained.

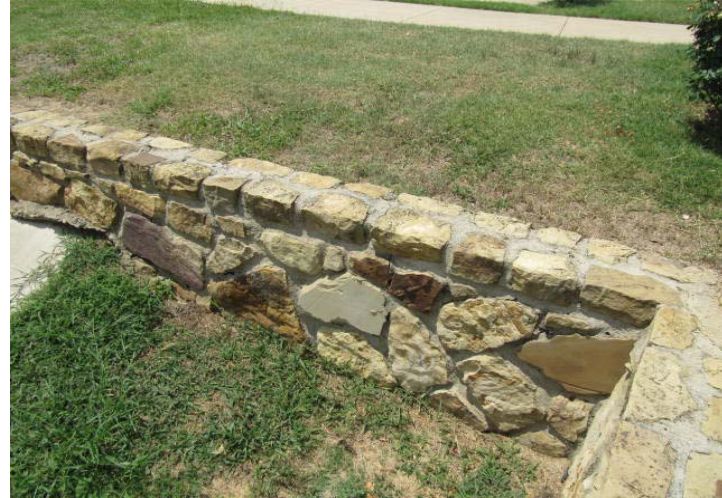
Retaining wall at end of cul-de-sac.

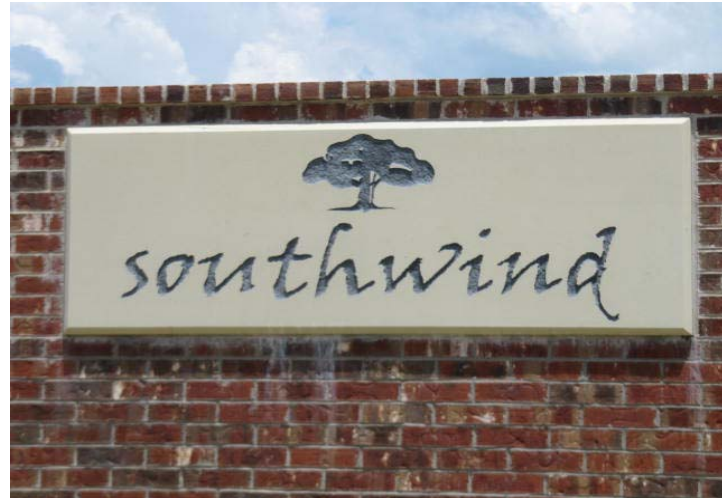
Precast signage at perimeter wall.

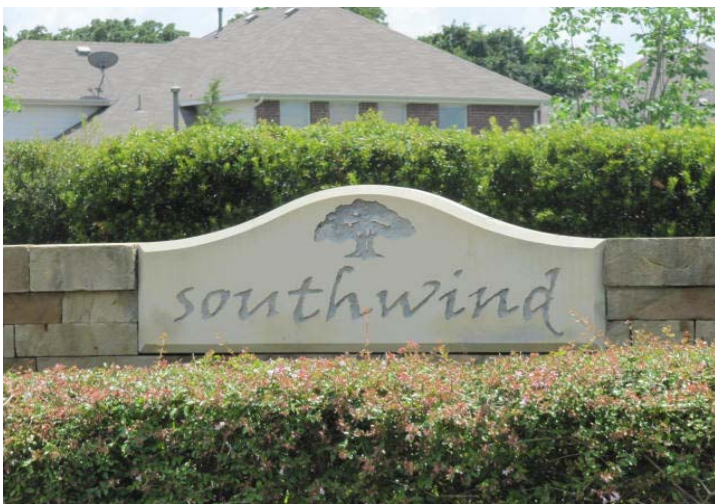
Precast signage near swimming pool area.

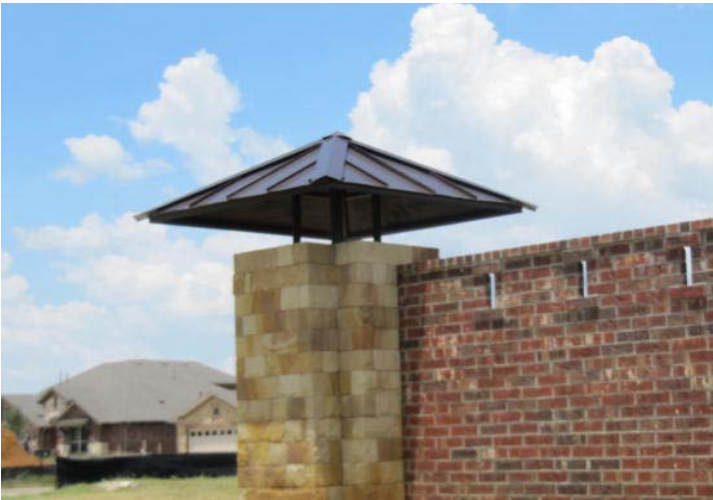
Overview of metal roof structure at perimeter wall.

Special Conditions
Decorative metal roof structures are located at entrance monuments. The roof structures are in good overall condition at 7 years of age, with good finishes. Unit cost includes the replacement of the aluminum standing seam roof panels and trim, as well as the wood and metal support structures. Replacement is forecasted for 2031 and coincides with the phased replacement of the cast stone entrance signage.

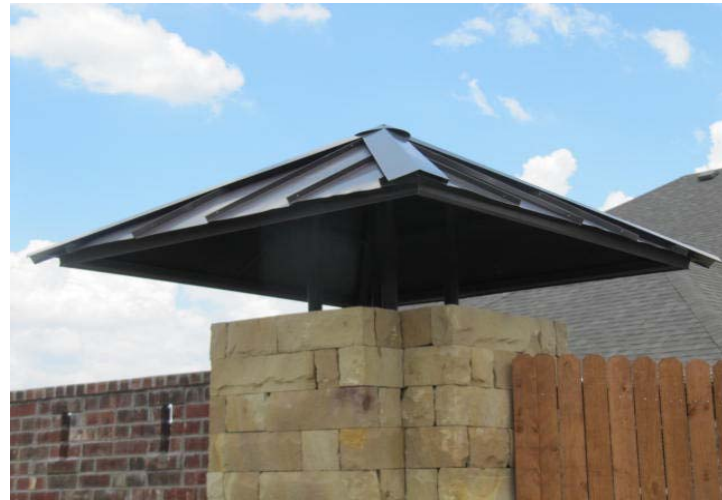
Peaked roof at monument signage, at property perimeter.

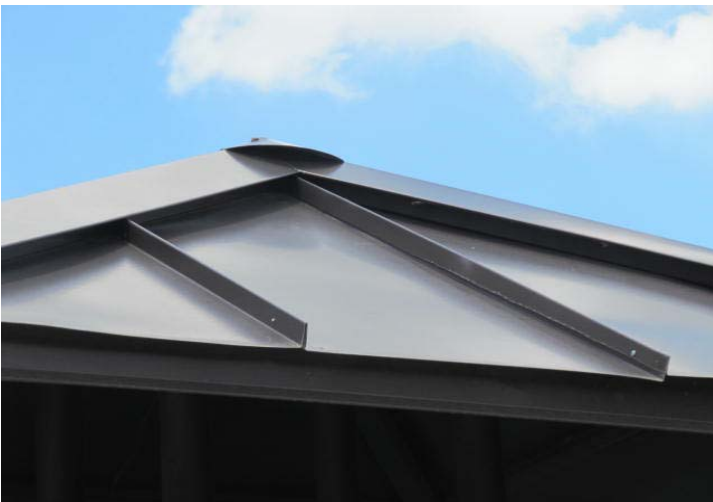
Standing seam aluminum roof panels.

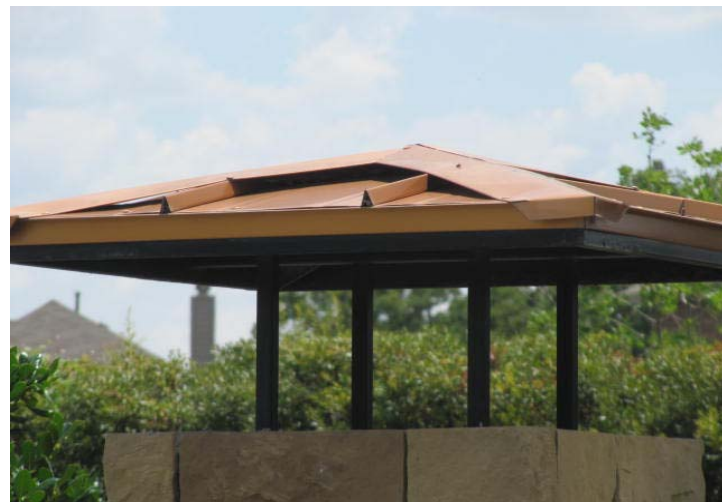
Roof structure at monument near swimming pool.

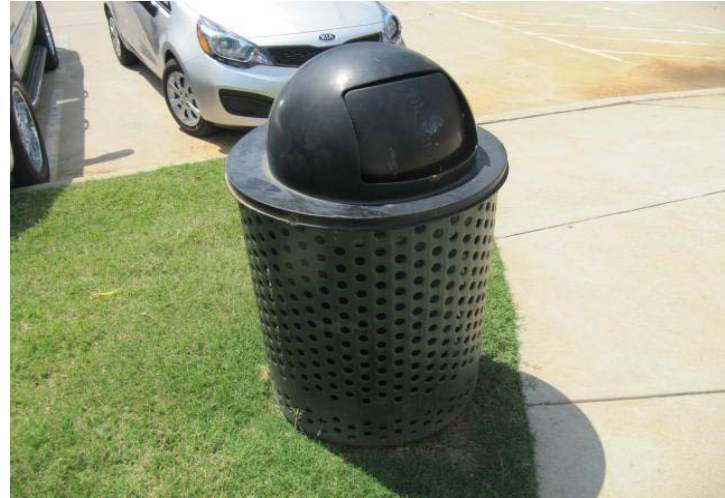
Waste receptacle near playground area.

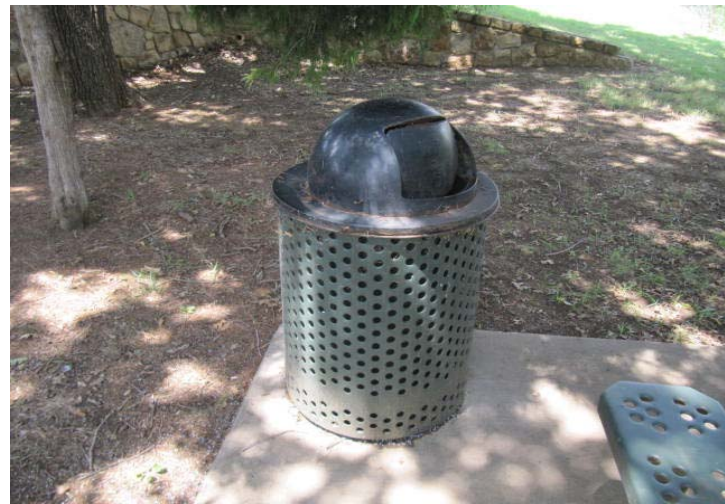
Waste receptacle near front pond area.

Special Conditions
Total quantity includes the following site furnishings: (1) picnic table near entrance pond at Southwind Drive, (2) in-ground mount benches, (2) waste receptacles by playground, (1) waste receptacle at picnic area near Southwind Drive pond, and (1) bike rack at playground area. Site furnishings are in good overall condition at 7 years of age. Replacement is forecasted when the items reach an age of 15 years.

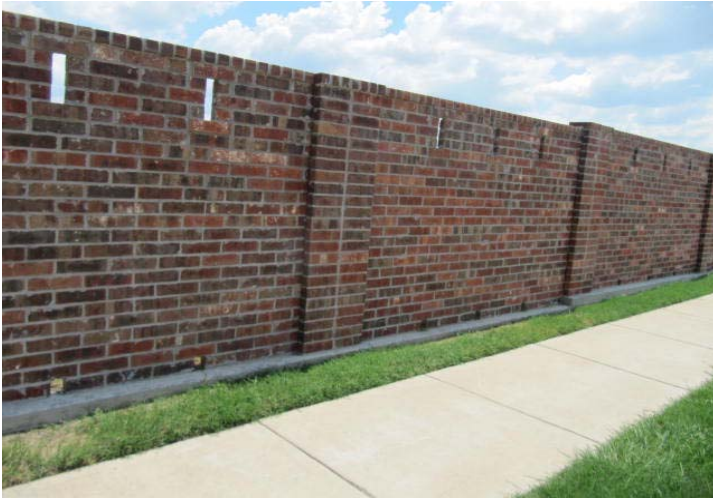
Overview of masonry perimeter wall.

Special Conditions
<p>Component includes full inspection and capital repairs as necessary at the masonry privacy walls at a portion of the property's boundary lines. Inspections and capital repairs at the masonry walls are forecasted every 10 to 15 years, beginning in 2023. The first phase of inspections and repairs is extended beyond the typical useful life due the walls' age and overall good condition.</p>

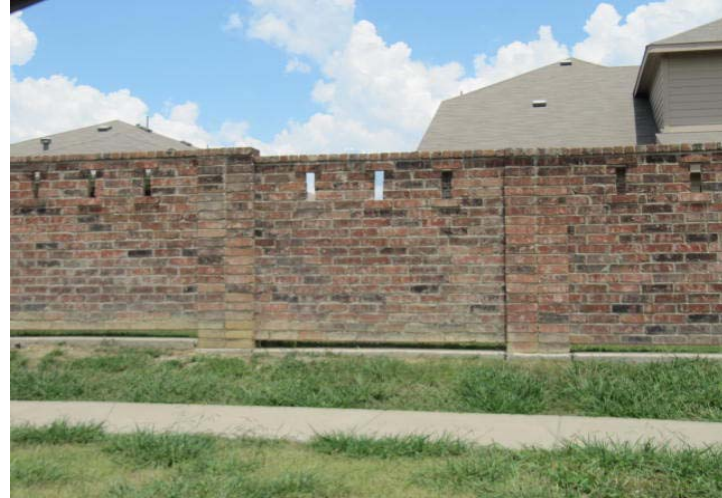
Overview of masonry perimeter wall.

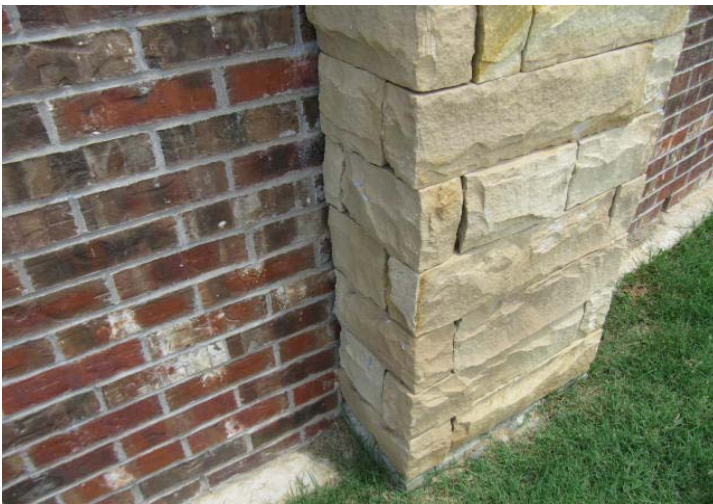
Brick wall panel and stone pier at property perimeter.
