RESERVE STUDY  
For  
**Southwind**

**Arlington, TX**  
Date of Inspection  
July 18, 2013

**BUILDING RESERVES, INC.**

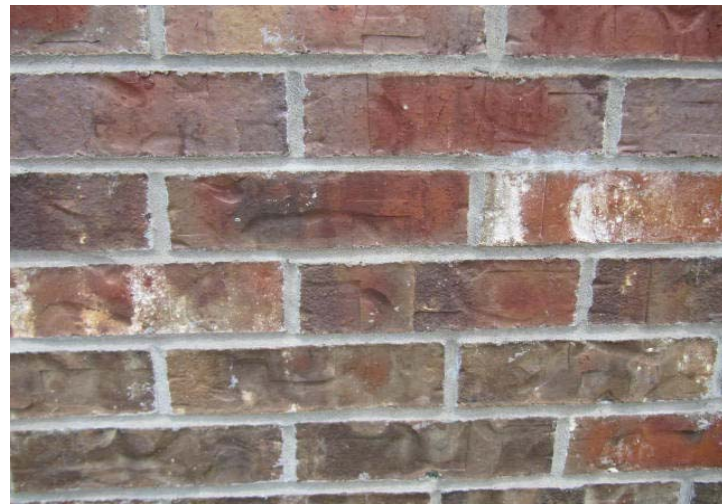
Typical condition of bricks and mortar joints.

Special Conditions
<p>Component includes full inspection and capital repairs as necessary at the masonry privacy walls at a portion of the property's boundary lines. Inspections and capital repairs at the masonry walls are forecasted every 10 to 15 years, beginning in 2023. The first phase of inspections and repairs is extended beyond the typical useful life due the walls' age and overall good condition.</p>

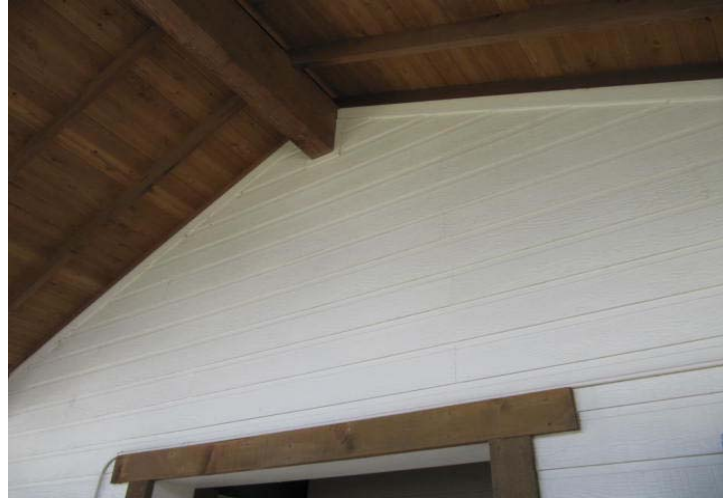
Composite siding at pool house exterior.

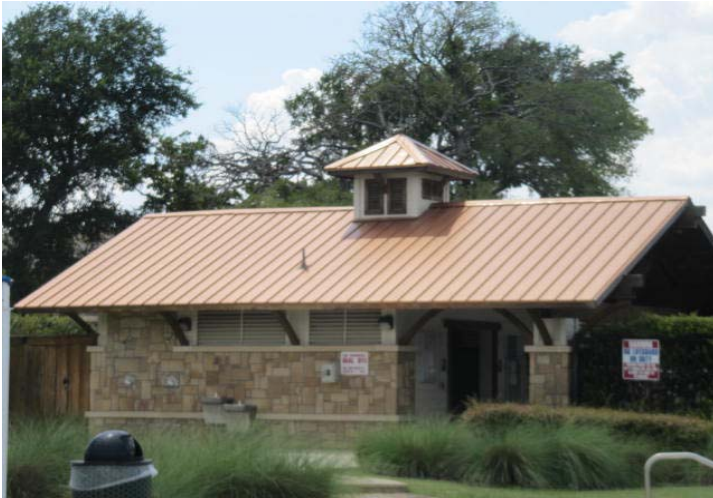
Overview of exterior of pool house.

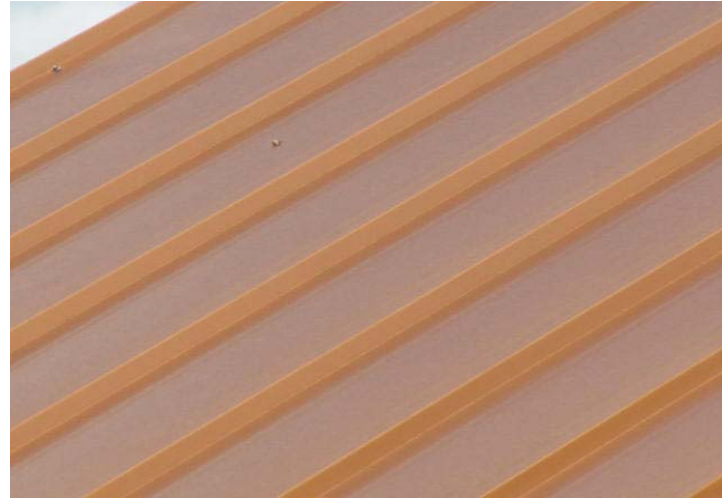
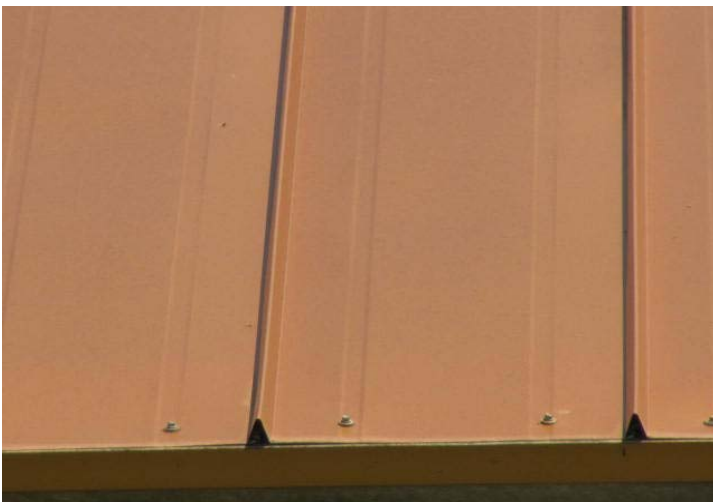
Aluminum standing seam roof at pool house.

Special Conditions
<p>An aluminum standing seam roof is located at the pool house building. The roof is currently in good overall condition at 7 years of age. The finish on the roof panels and trim is in good overall condition, and no major leaking or water infiltration issues were reported by management. Replacement of the roof is forecasted for 2041, when the roof reaches an age of 35 years.</p>

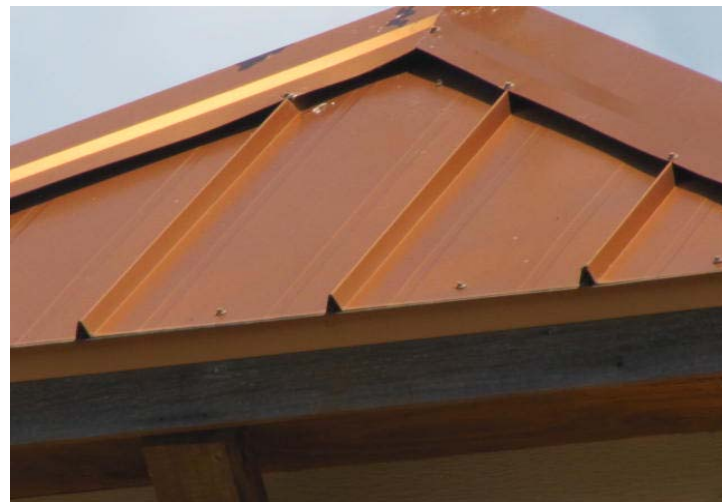
Good finishes at metal roof panels.

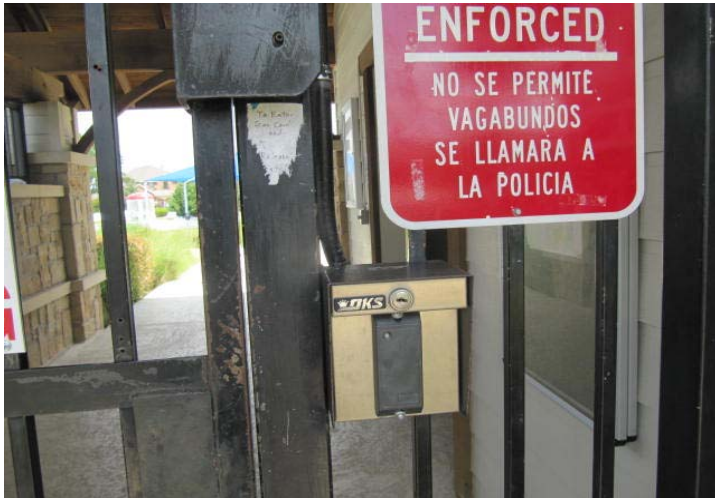
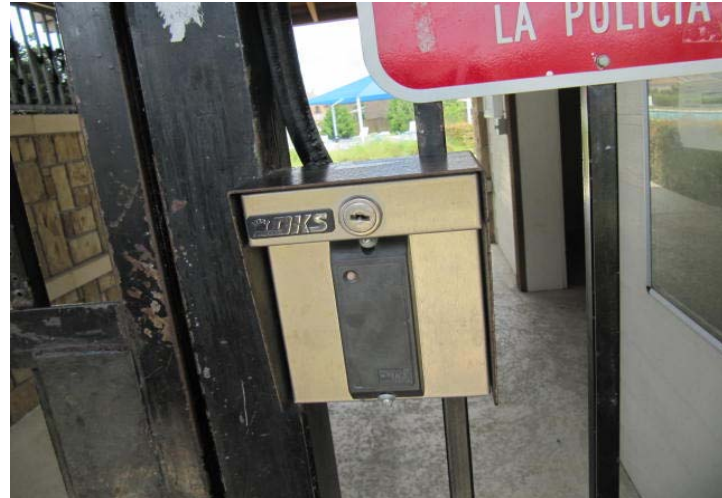
Overview of FOB access / proximity card reader.

Component includes the replacement of the gate proximity card reader and exit button (located inside of pool area) at the swing style pool gate. The proximity card reader and exit button are in good functional condition at 7 years of age. Replacements of the proximity card reader and exit button are forecasted at 15-year intervals.

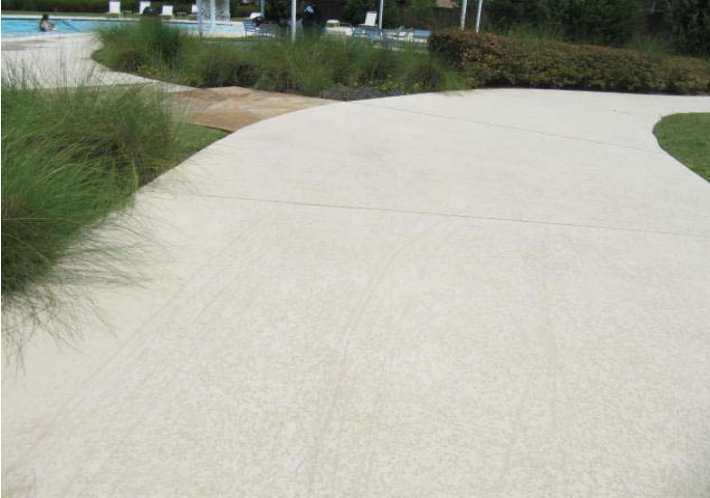
Overview of textured pool deck.

Special Conditions
<p>The concrete swimming pool deck was resurfaced in 2012 and is currently in very good condition. Unit cost includes removal of existing texture surface, crack filling as needed, and new spray-deck texture surface application. Total quantity includes the pool deck as well as the interior floor surfaces of the restroom.</p>

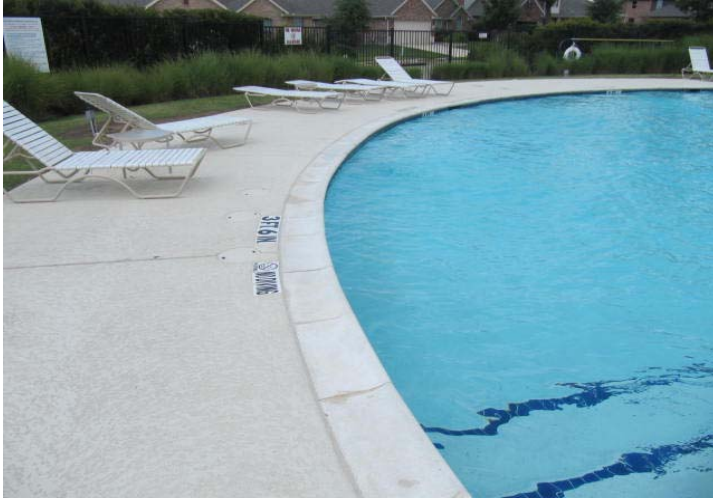
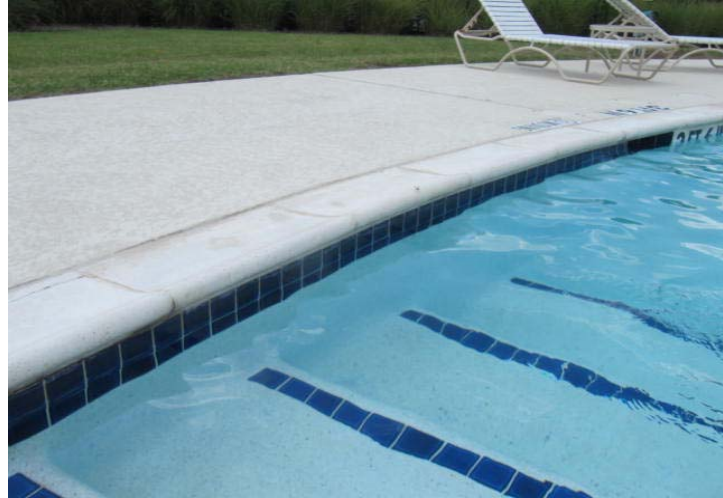
Pool coping at perimeter of swimming pool.

Special Conditions
<p>Concrete coping is located at the perimeter of the swimming pool (with the exception of the zero-depth end). Coping is in fair overall condition at 7 years of age, with isolated cracking at coping pieces. Replacement of the concrete coping is forecasted for 2024, and again 18 years thereafter. Coping replacement coincides with pool resurfacing and waterline tile replacement.</p>

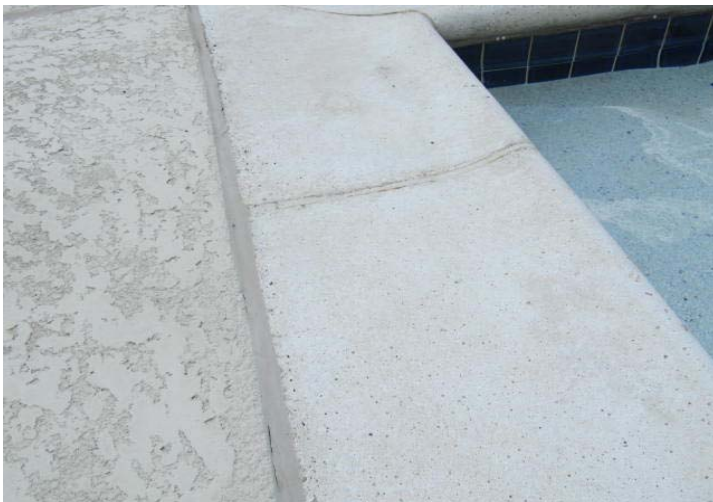
Formed concrete coping at perimeter of pool.

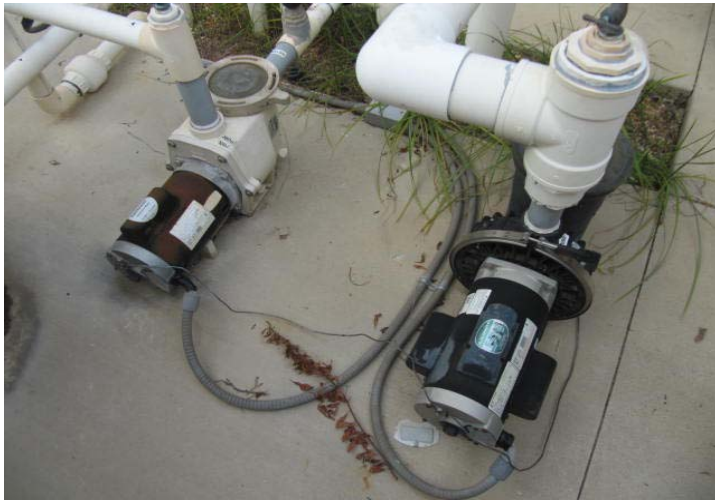
Circulating pumps for swimming pool.

(4) circulating pumps serve the swimming pool. (3) circulating pumps are rated for 2.0-Horsepower, and (1) circulating pump is 5.0-Horsepower. Circulating pumps vary in age but are currently in good functional condition. Replacement of the circulating pumps is forecasted every 10 years, beginning in 2018. In 2038, pump replacement coincides with pool filter replacements.

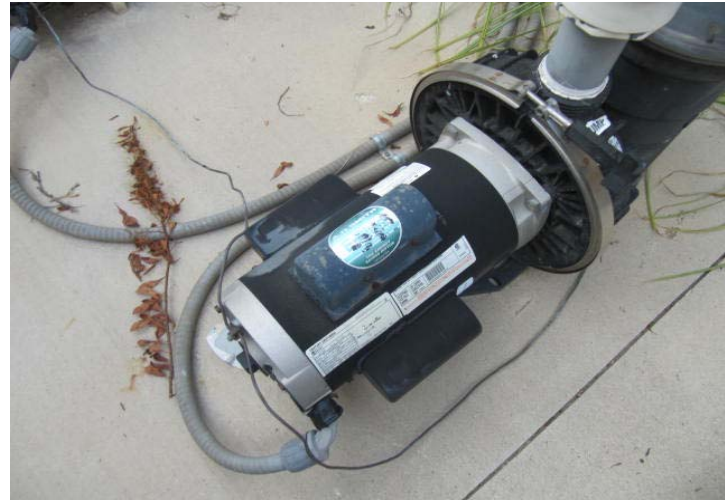
Circulating pump, at wood enclosure near pool house.

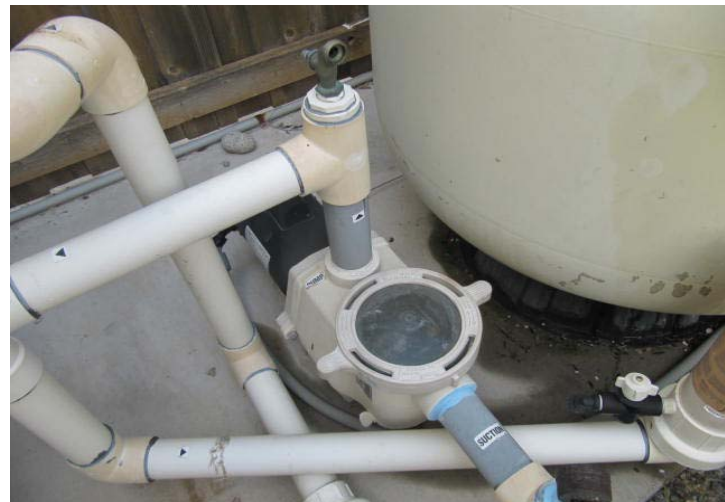
Pool circulating pump, in good functional condition.

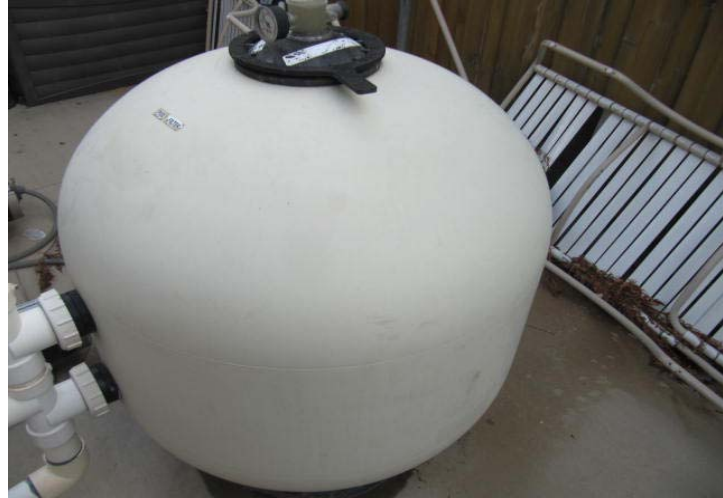
Typical sand filter at swimming pool.

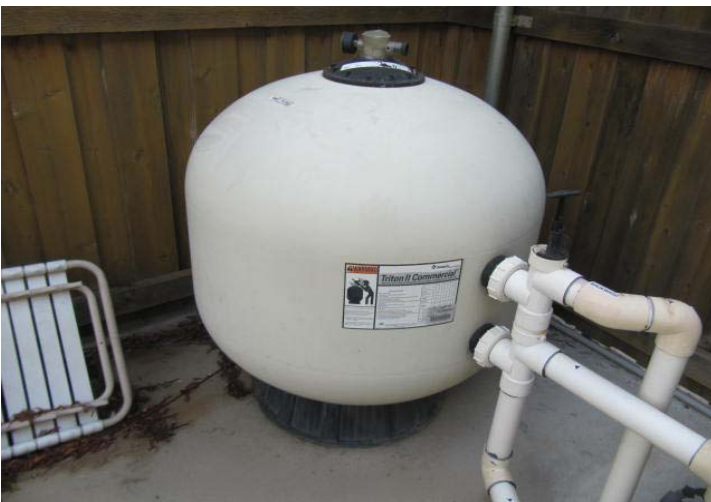
Typical sand filter at swimming pool.

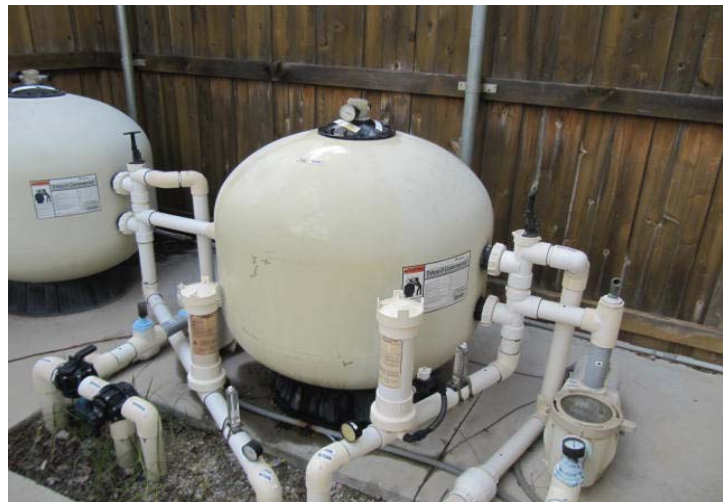
Original pool filter, in good functional condition.

Special Conditions
<p>(3) TRITON sand filters serve the swimming pool. The original filters are in good functional condition at 7 years of age. Replacement of the pool filters is forecasted for 2023, and again 15 years thereafter. Replacement of the pool filters in 2038 coincides with the replacement of the pool circulating pumps. Prior to full filter replacement, sand replacement should be funded as needed as an operational expense.</p>

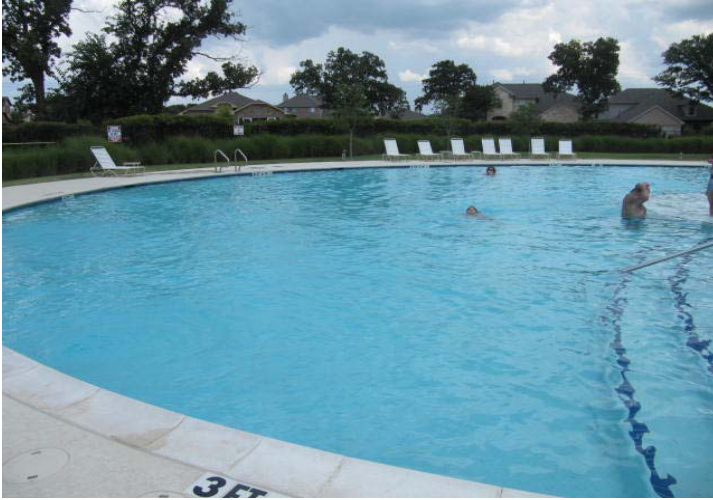
Overview of swimming pool.

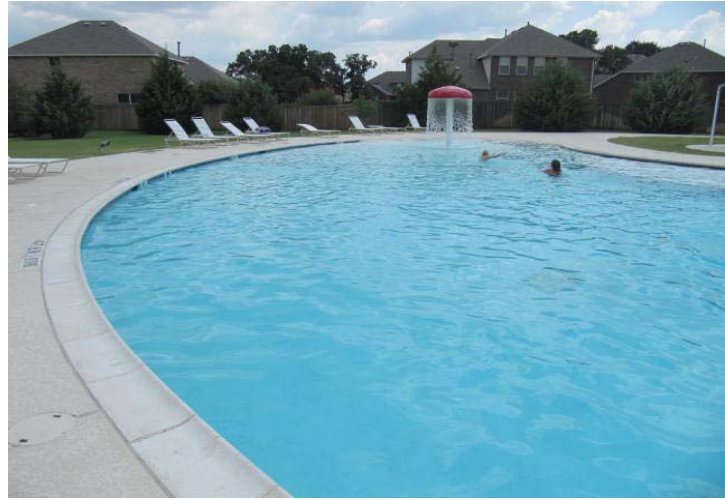
Diamond-Brite finish at pool interior.

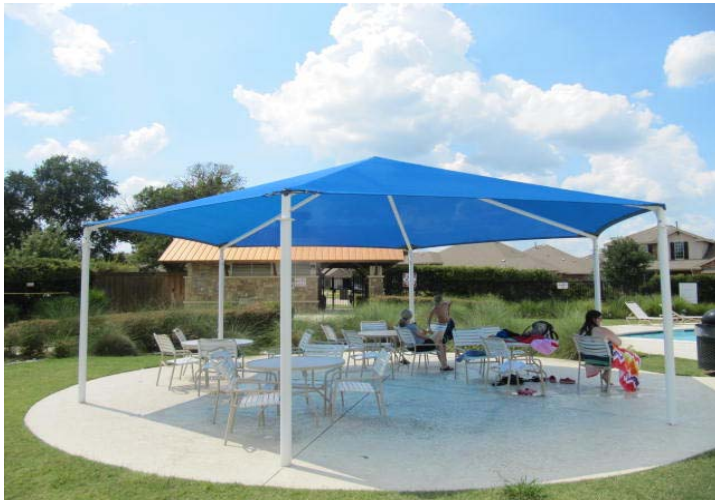
Overview of sunshade structure.

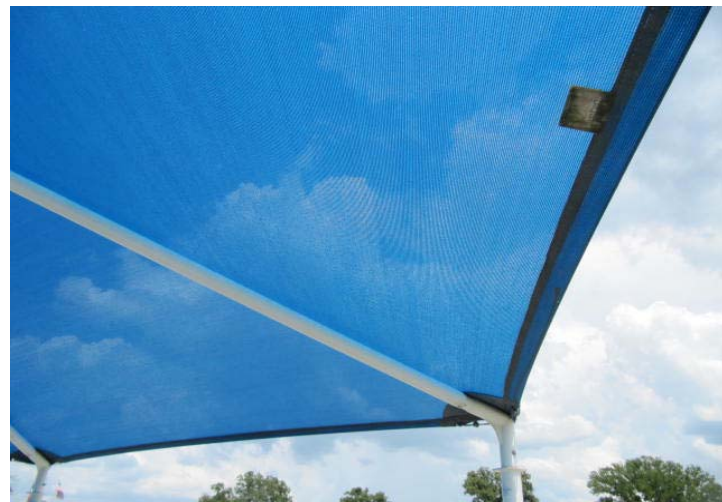
Original sunshade, in good overall condition.

Special Conditions
<p>(1) shade structure is located at the swimming pool area. Unit cost includes hexagonal shade structure with commercial grade shade fabric, steel posts and canopy structure, engineered drawings, removal of existing structure, and installation of new structure. Replacement of the sun shade structure is forecasted for 2012, and again 15 years thereafter. In 2036, replacement coincides with pool deck resurfacing.</p>

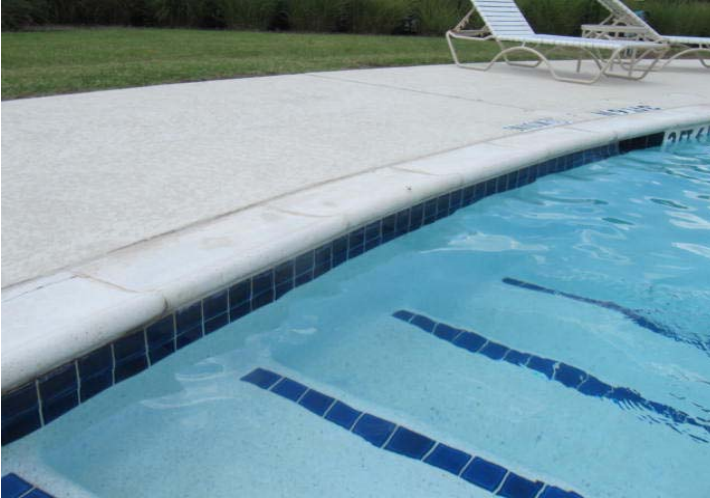
Overview of waterline tile at swimming pool.

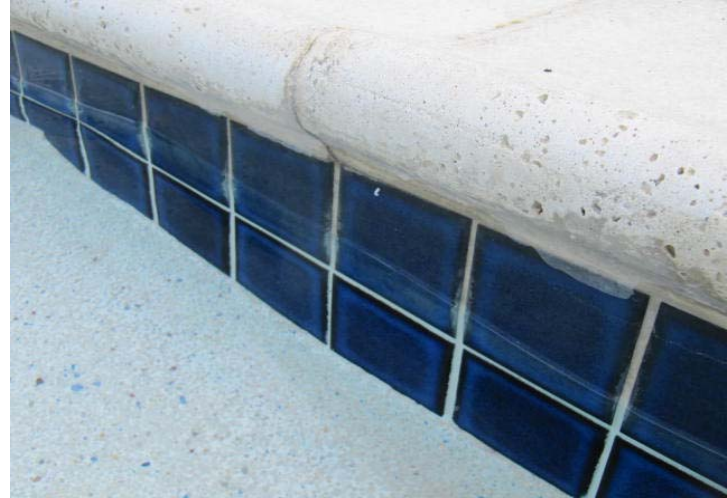
Typical condition of waterline tile at pool perimeter.

Waterline tile is located at the perimeter of the swimming pool (with the exception of the zero-depth end). Waterline tile is in fair overall condition at 7 years of age, with isolated cracking below coping pieces. Full replacement of the waterline tile is forecasted for 2024, and again 18 years thereafter. Tile replacement coincides with pool resurfacing and pool coping replacement.

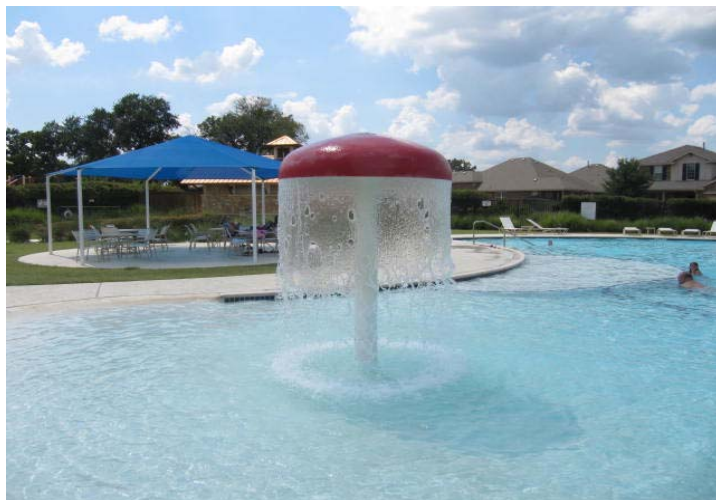
Overview of water feature at swimming pool.

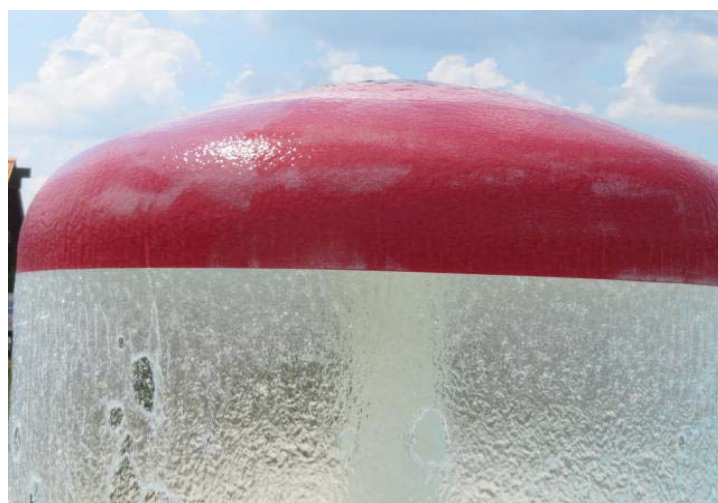
Good finishes at water feature - recent painting funded from operating budget.
