RESERVE STUDY  
For  
**Southwind**

**Arlington, TX**  
Date of Inspection  
July 18, 2013

**BUILDING RESERVES, INC.**

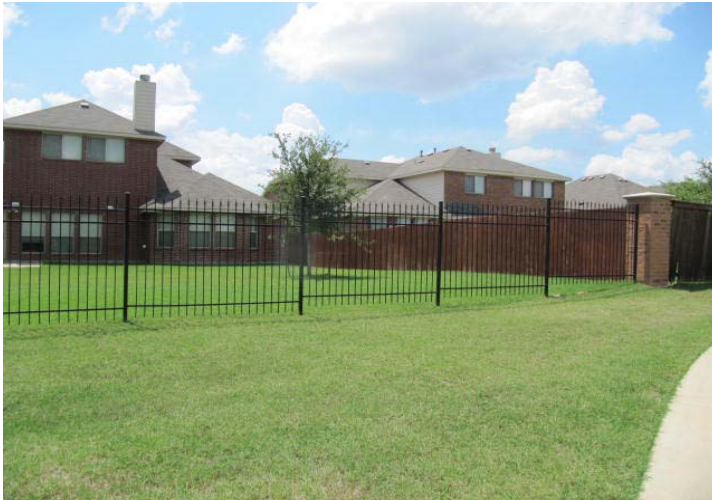
Fence at rear of homeowner lot, at easement area.

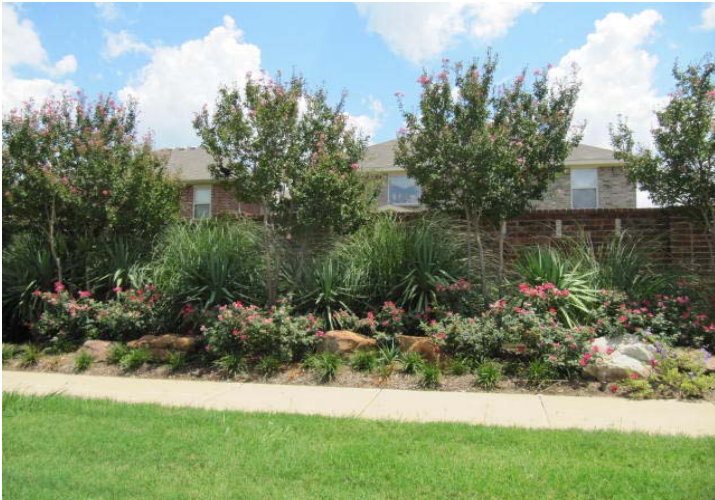
Landscaping at property perimeter, near signage.

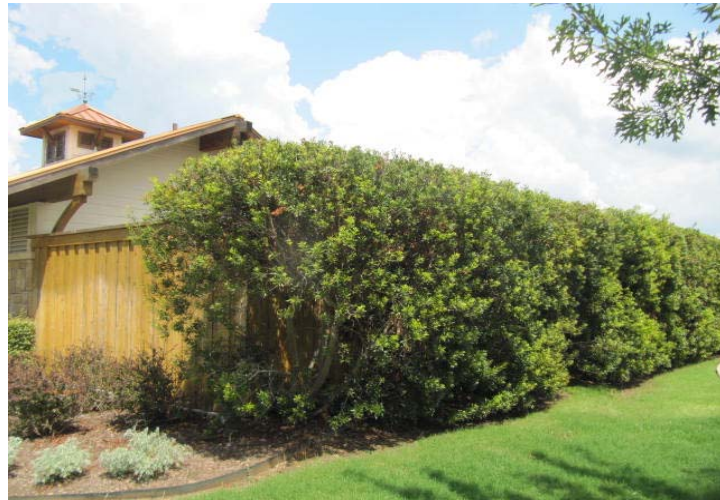
Privacy hedge near swimming pool.

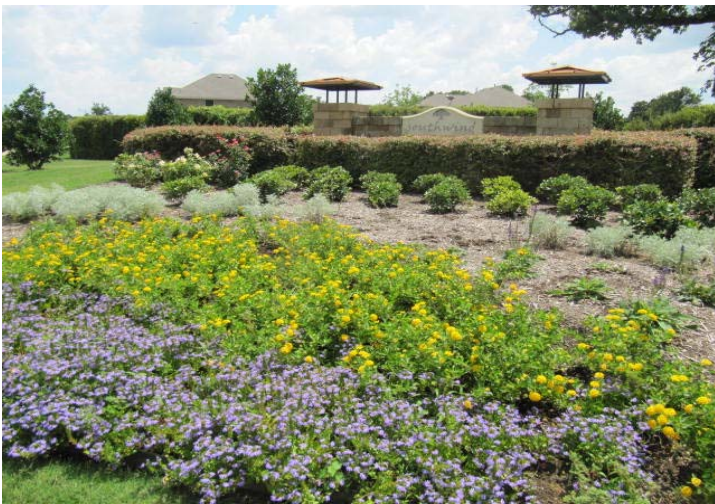
Planting bed near monument sign near pool.

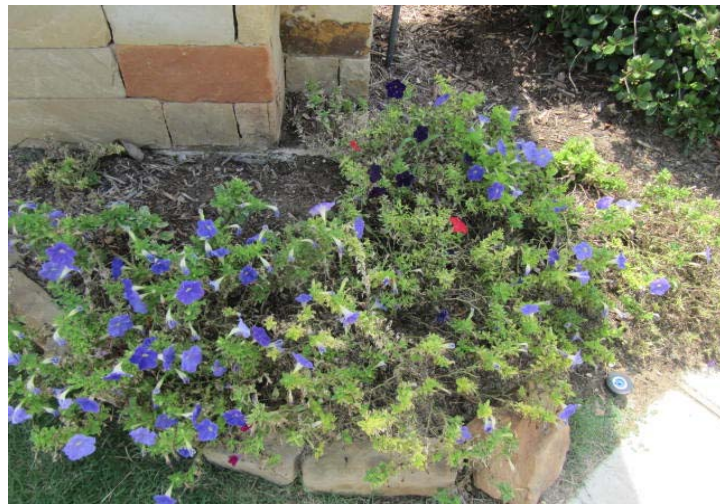
Flowering plant near signage.

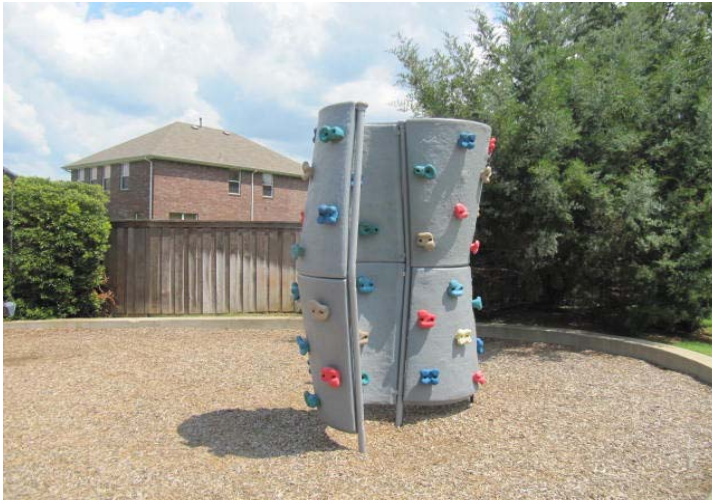
Overview of climbing wall.

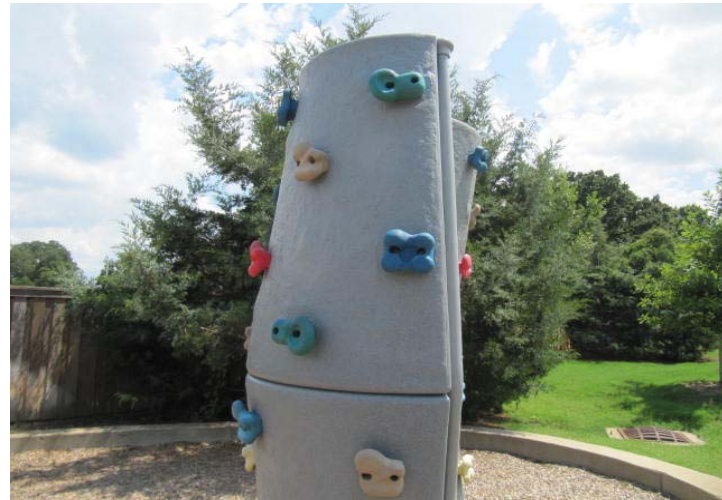
Climbing wall at playground area.

Special Conditions
(1) commercial climbing wall is located at the playground area. The climbing wall is in good overall condition at 7 years of age, with good finishes. Replacement is forecasted for 2028 and coincides with the replacement of the adjacent play structure and swing set. Prior to full replacement, isolated peg replacement should be funded as needed as an operational expense.

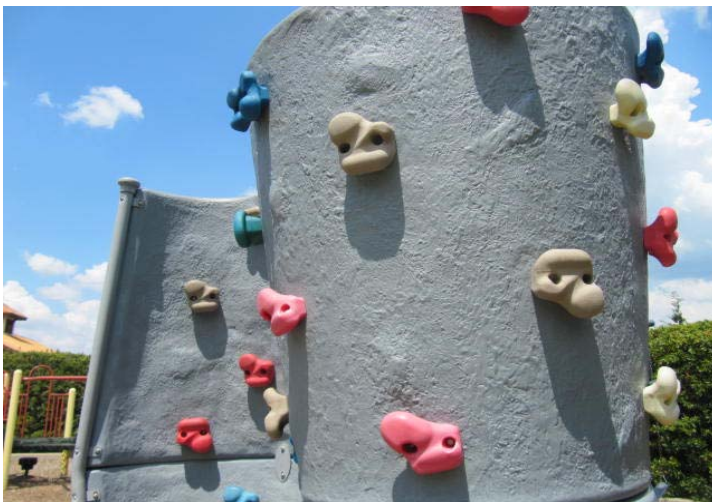
Wall at playground with climbing pegs.

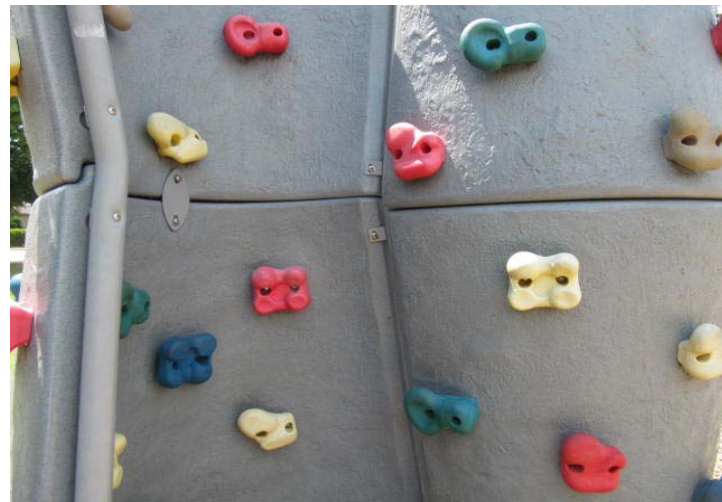
Wall at playground with climbing pegs.

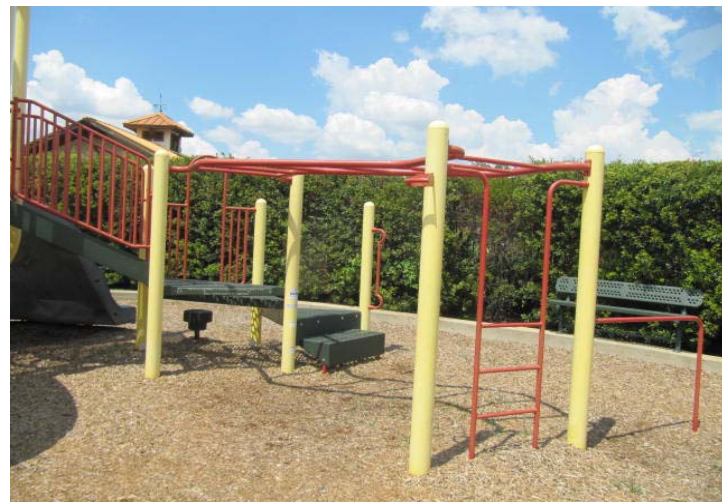
Monkey bars and ladder at playground structure.

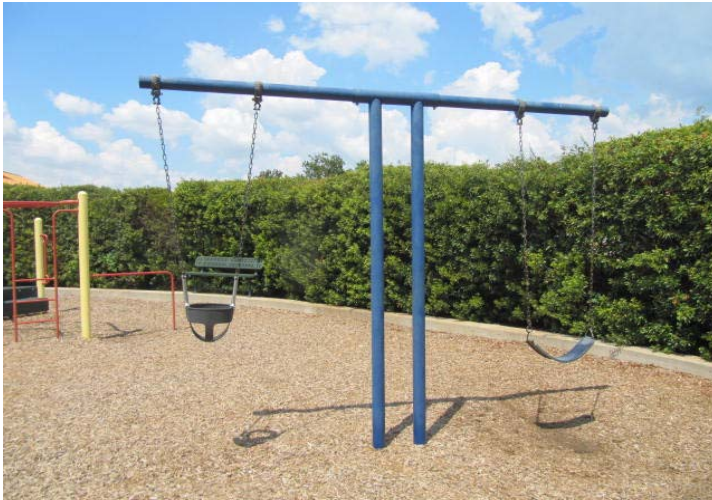
Swing set at playground.

Special Conditions
(1) commercial swing set is located at the playground area. The swing set is in good overall condition at 7 years of age, with worn finishes at the metal structure. Replacement is forecasted for 2028 and coincides with the replacement of the adjacent play structure and climbing wall. Prior to full replacement, swing replacement and paint finishes should be funded as needed as operational expenses.

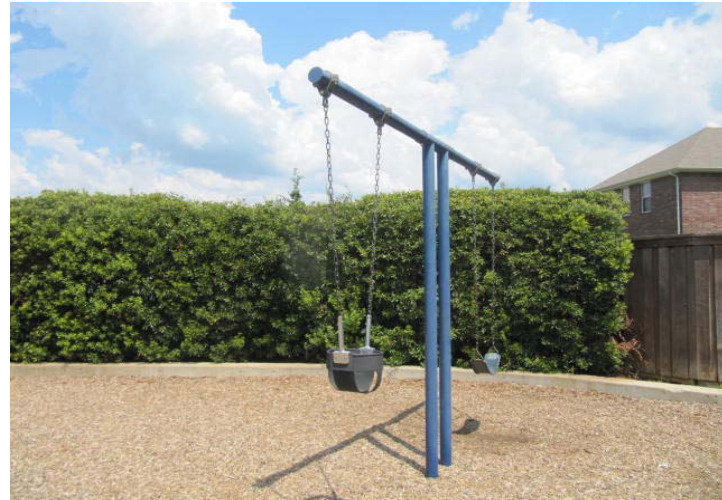
Swing set at playground.

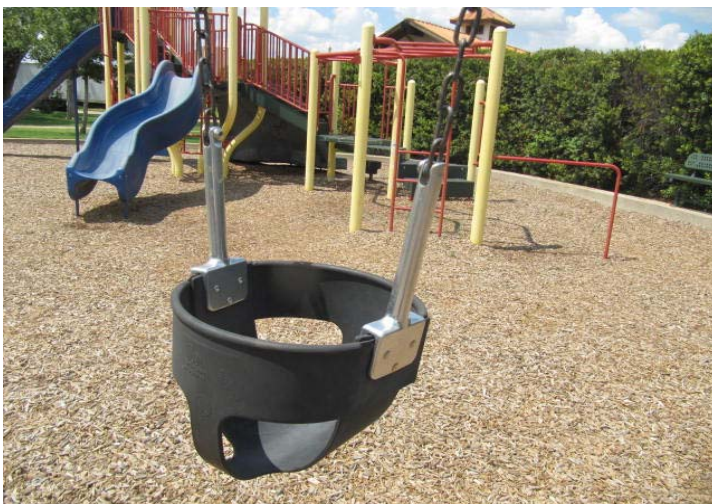
Toddler swing at playground area.

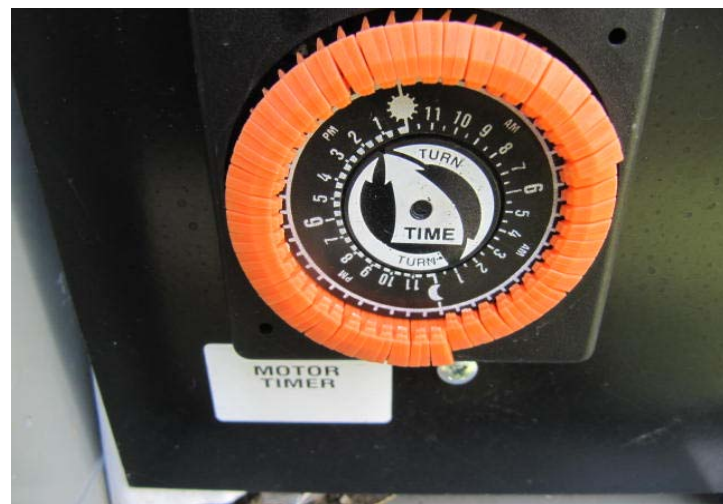
Timer for motor at pond fountain.

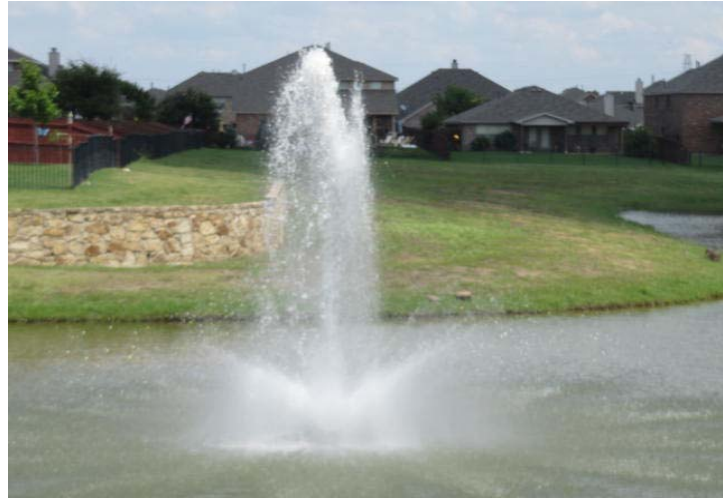
Floating pond aerator with lighting.

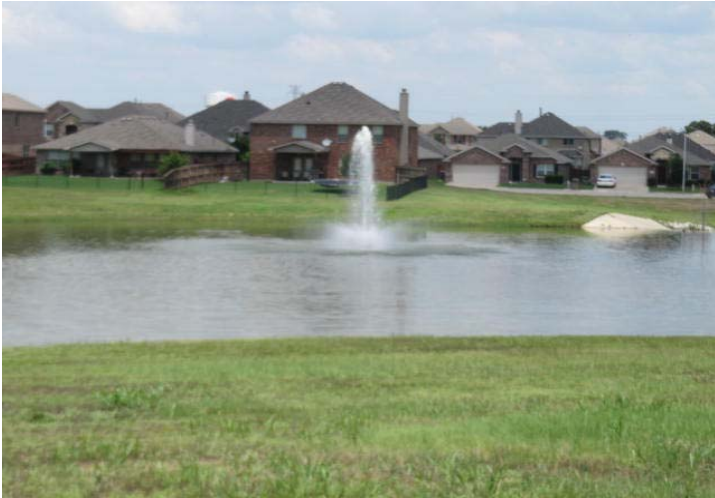
Overview of pond at Southwind.

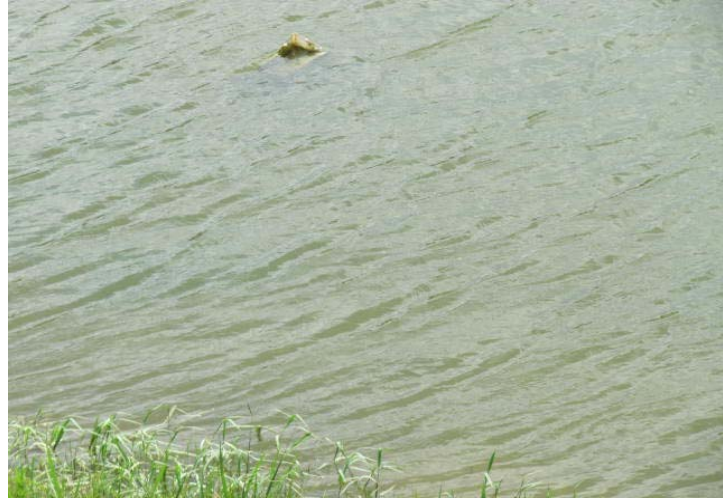
Pond water shows movement from aerator.

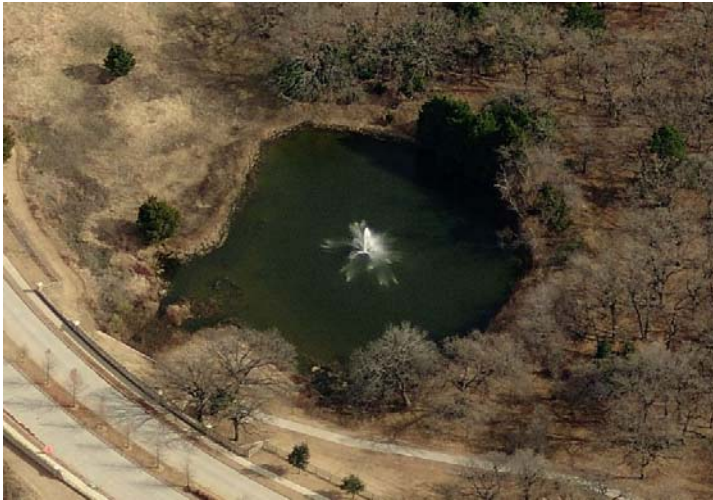
Aerial view of front pond with low water.

Special Conditions
<p>The pond at the Southwind Drive entrance is very shallow, and the aerator does not run the majority of the time. The bottom of the pond has very sandy soil, and pond water slowly percolates into the ground. Proposed solution includes the installation of a clay pond liner. Cost includes pumping of the existing pond (removal of water), installation of a high-PI (plasticity index) clay liner between 10" and 18" thick, and refilling of pond.</p>

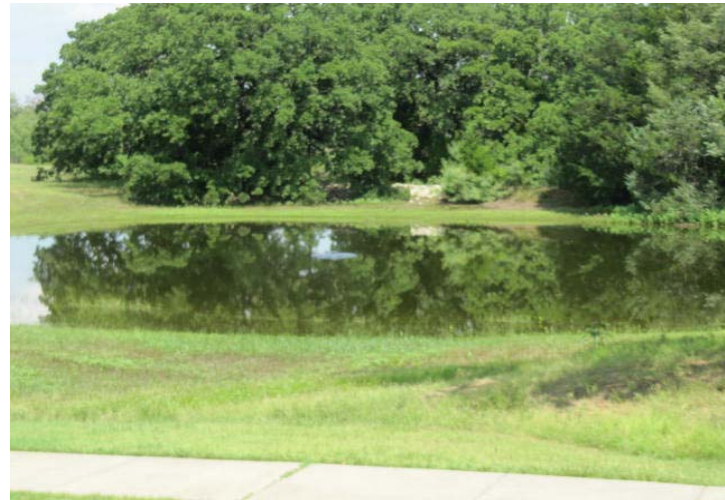
Overview of front pond with low water.

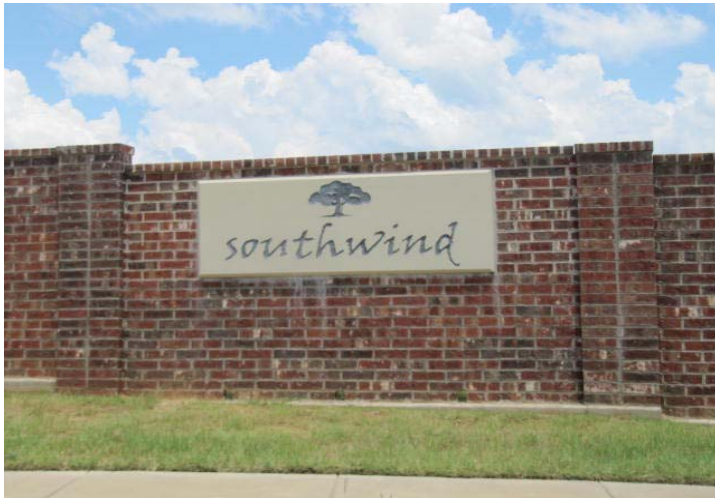
Overview of precast signage.

Special Conditions
Cast stone signage is located at both sides of the entrance roads at Corbin Dr., Water Oak Dr.(both ends of street), Promise Creek Dr., and Southwind Dr. Total quantity also includes the cast stone sign near the pool / amenity center. Phased replacement is forecasted, beginning in 2021. Replacement in 2031 coincides with the replacement of the metal roof structures near the entrance monuments.

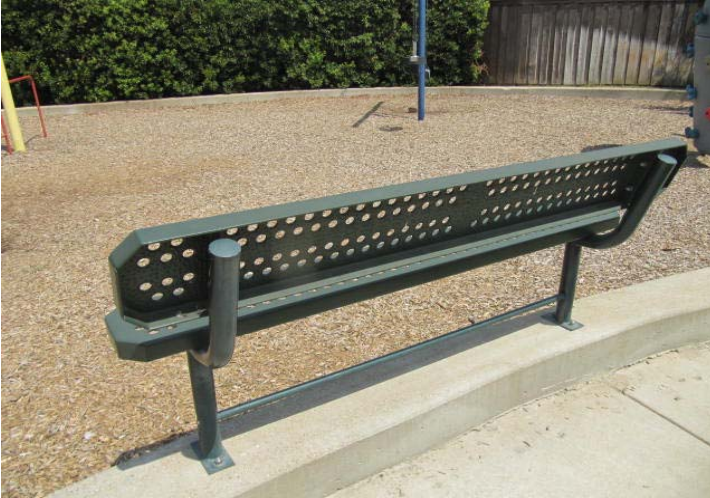
Bench near playground area.

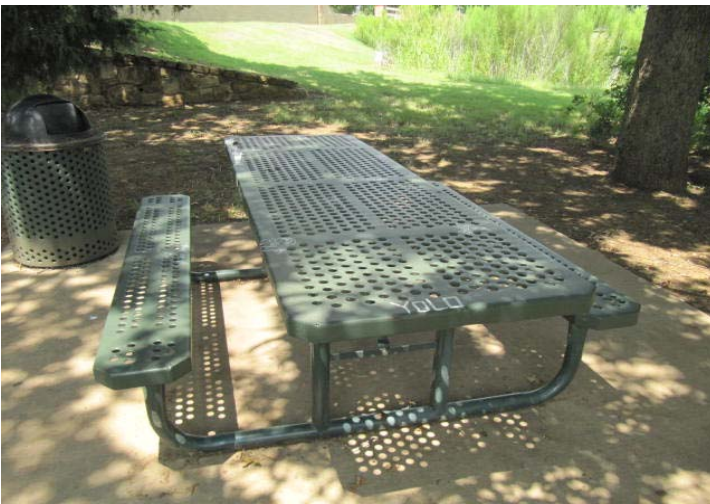
Picnic table near front pond area.

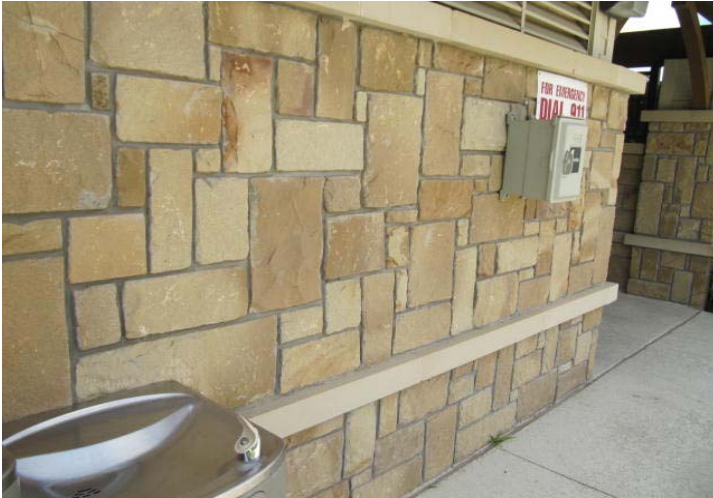
Overview of pool house exterior.

Special Conditions
Exterior renovations at the pool house include the following: masonry repairs, replacement of siding and trim, stain finishes at wood ceiling and trim, exterior light fixtures, replacement of metal railing at entrance, and metal signage letters at rail. Exterior renovations at the pool house are forecasted between 20 and 25 years of age and coincide with restroom renovations at the pool house. General maintenance, including paint finishes, should be performed as needed and should be funded from the association's operating budget.

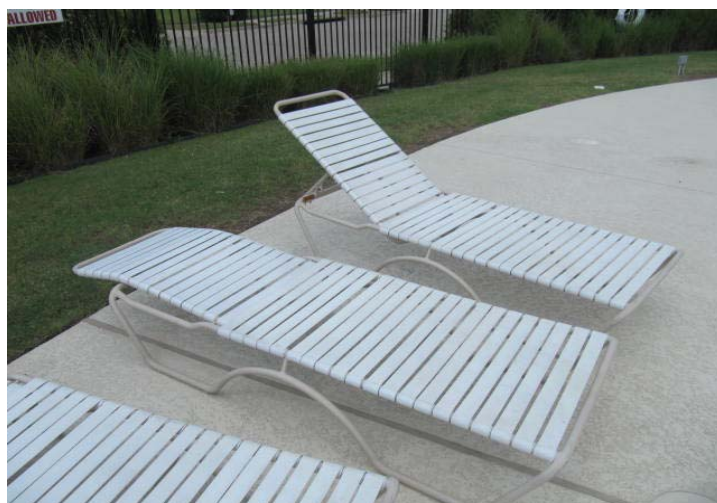
Pool chaise lounges are in good overall condition.

(22) strap-style chaise lounges are located at the swimming pool area. The chaise lounges are in good overall condition at varied ages. Full replacement of all chaise lounges is forecasted every 9 years, beginning in 2019. Replacements coincide with the replacement of the pool dining chairs and the pool tables.

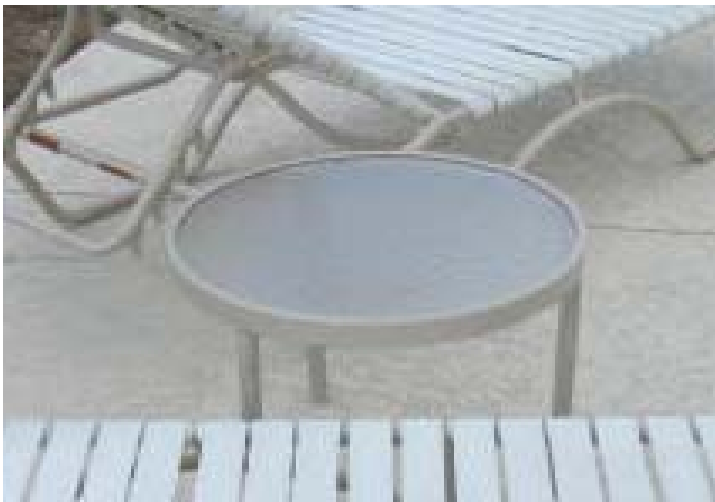
Small gals side table between adjacent chaise lounges.

(4) 42" dining tables and (8) 20" cocktail tables are located at the swimming pool area. (9) new tables were purchased in 2013 (3 dining tables and 6 cocktail tables). Tables are in good overall condition. Full replacement of all tables is forecasted every 9 years, beginning in 2019. Replacements coincide with the replacement of the pool chaise lounges and chairs. Unit cost is based upon actual 2013 expenditures.

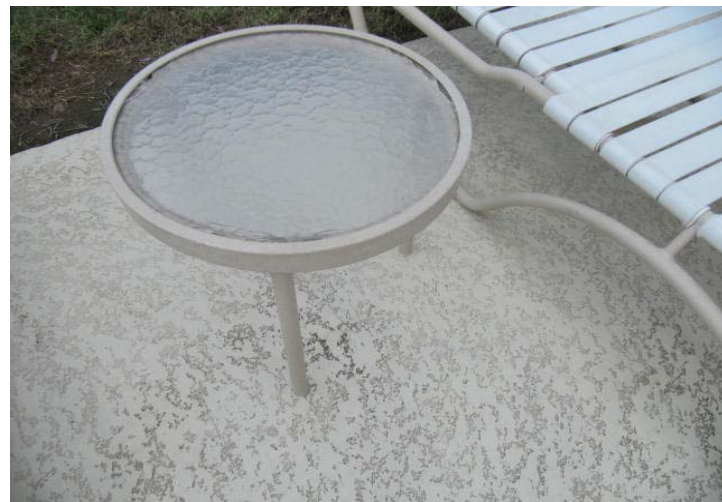
Small gals side table between adjacent chaise lounges.

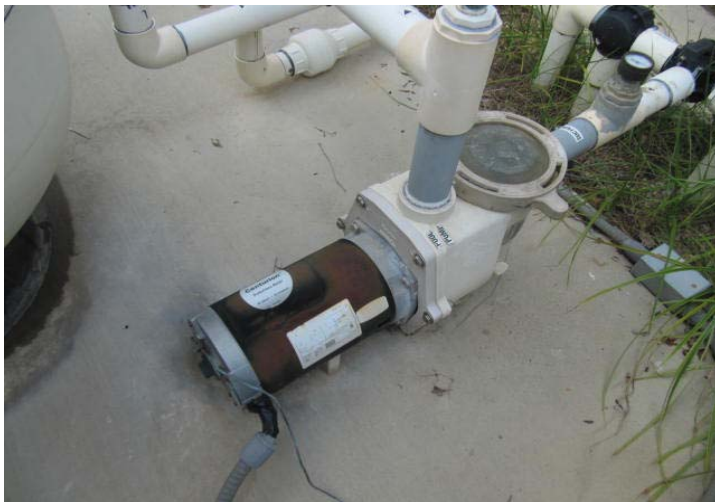
Circulating pump, at wood enclosure near pool house.

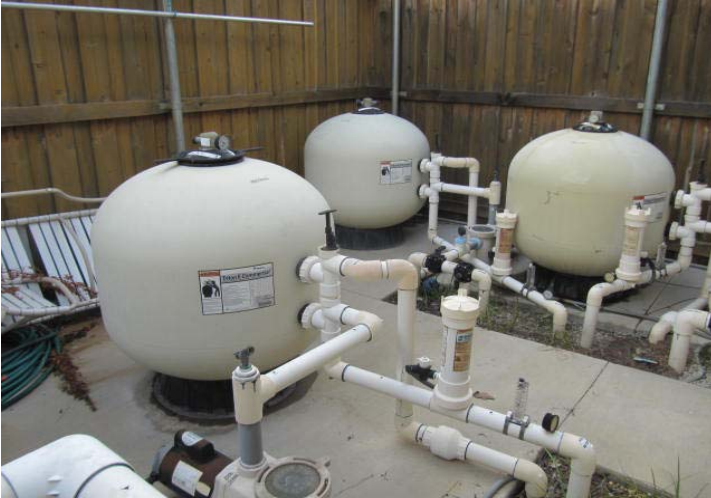
Overview of pool filters.

Special Conditions
<p>(3) TRITON sand filters serve the swimming pool. The original filters are in good functional condition at 7 years of age. Replacement of the pool filters is forecasted for 2023, and again 15 years thereafter. Replacement of the pool filters in 2038 coincides with the replacement of the pool circulating pumps. Prior to full filter replacement, sand replacement should be funded as needed as an operational expense.</p>

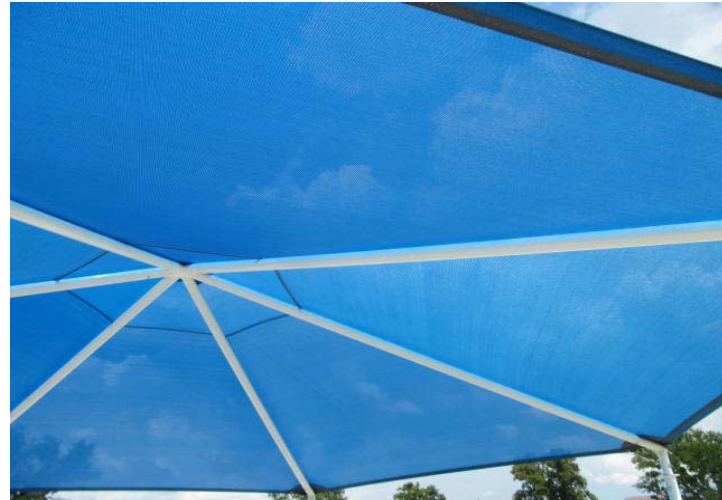
Metal frame with sunshade fabric.

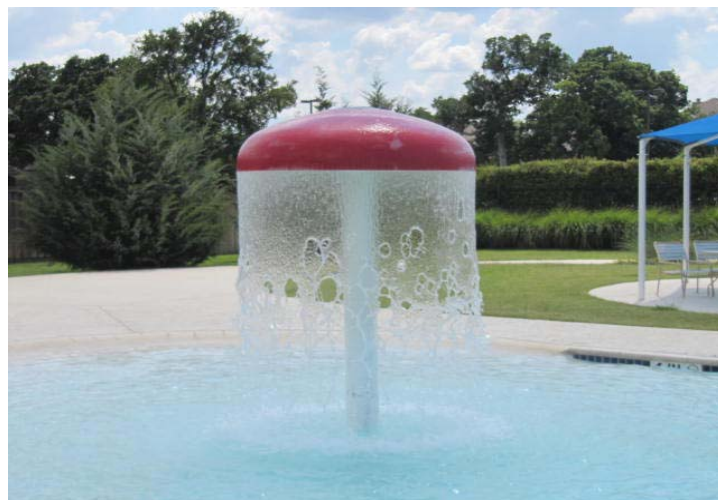
Mushroom / umbrella feature at swimming pool.

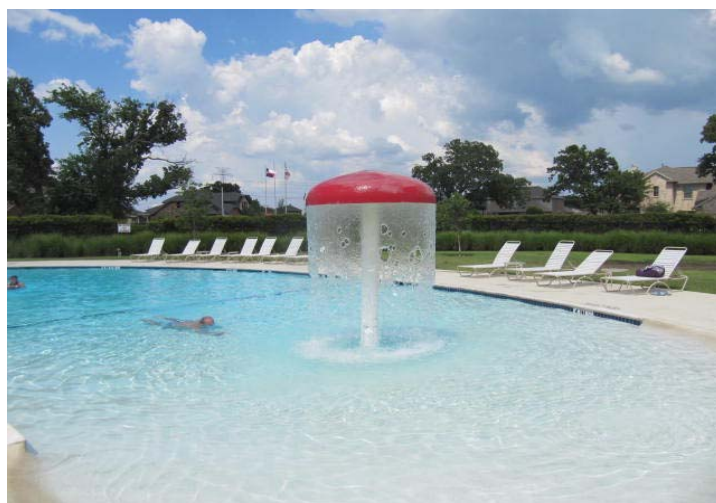
Mushroom / umbrella feature at swimming pool.
